ENVIRONMENTAL IMPACT ASSESSMENT FOR THE PROPOSED HOTAZEL 2 SOLAR PV
FACILITY AND ASSOCIATED INFRASTRUCTURE, HOTAZEL, NORTHERN CAPE:

FAUNA & FLORA SPECIALIST EIA REPORT

February 2021

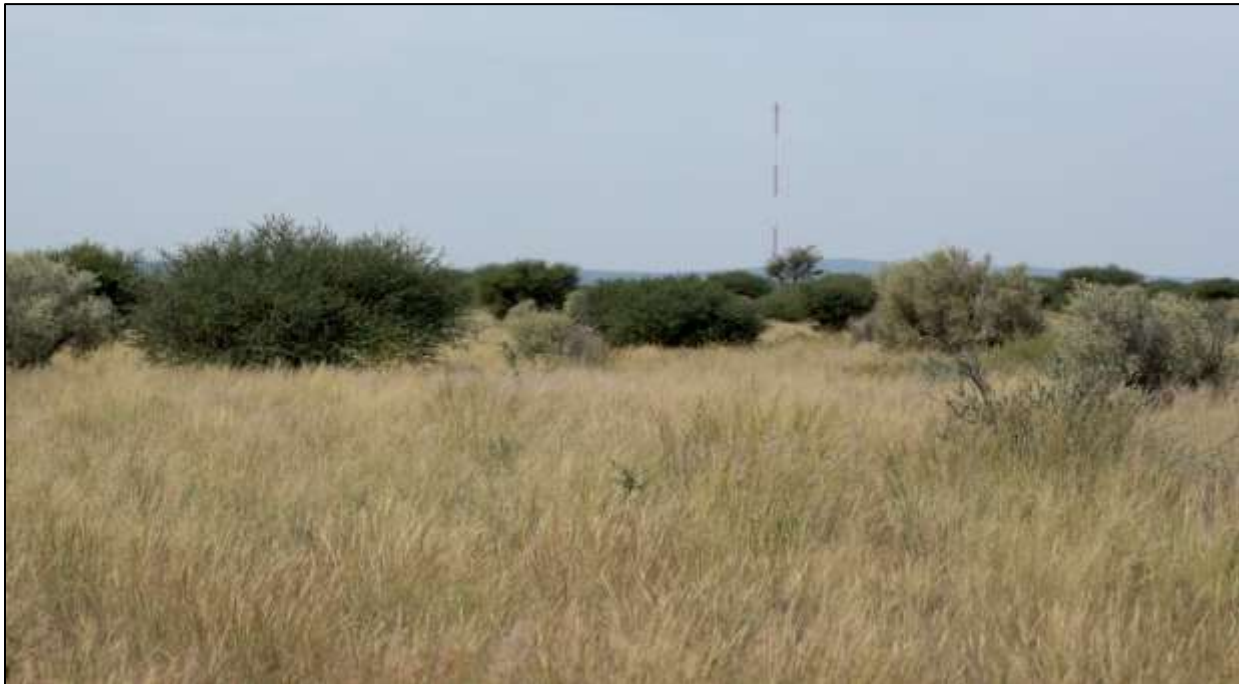
Figure 3. The south-eastern corner of the development area, showing the slightly higher density of trees in this area which are comprised mostly of *Senegalia mellifera* with occasional *Vachellia haematoxylon* and *V.erioloba*.

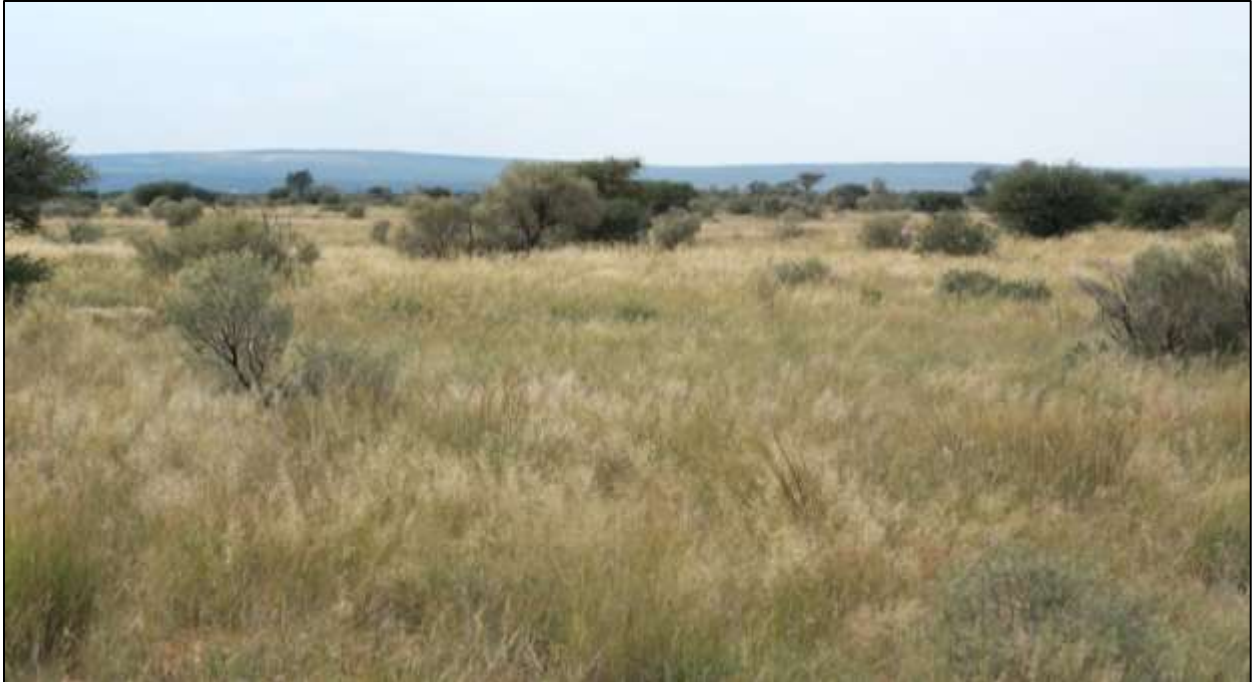
Figure 4. Typical vegetation of the site with scattered *Vachellia haematoxylon* and *V.erioloba* within a matrix of grasses.

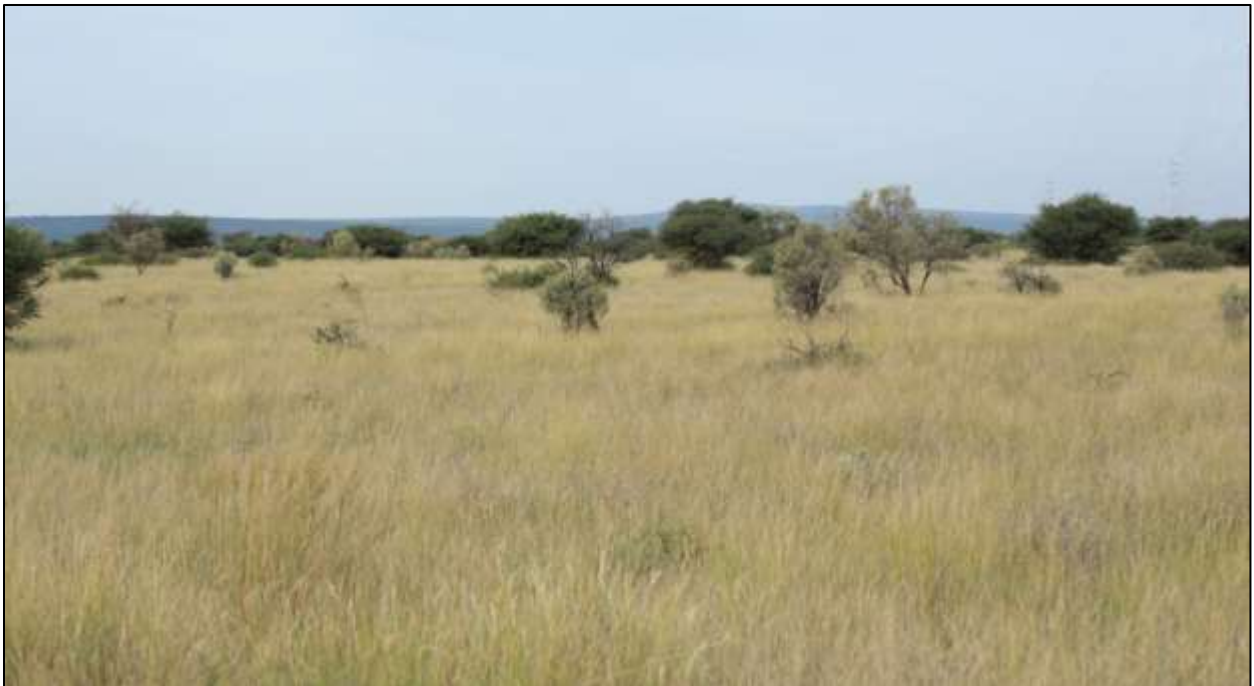
Figure 5. The typical vegetation within the proposed Hotazel 2 footprint consists of a well-developed grass layer with occasional *Vachellia haematoxylon* and *Senegalia mellifera*. Some of these more open areas have likely been achieved through the application of herbicides to eliminate bush-thickening species such as *Senegalia mellifera*.

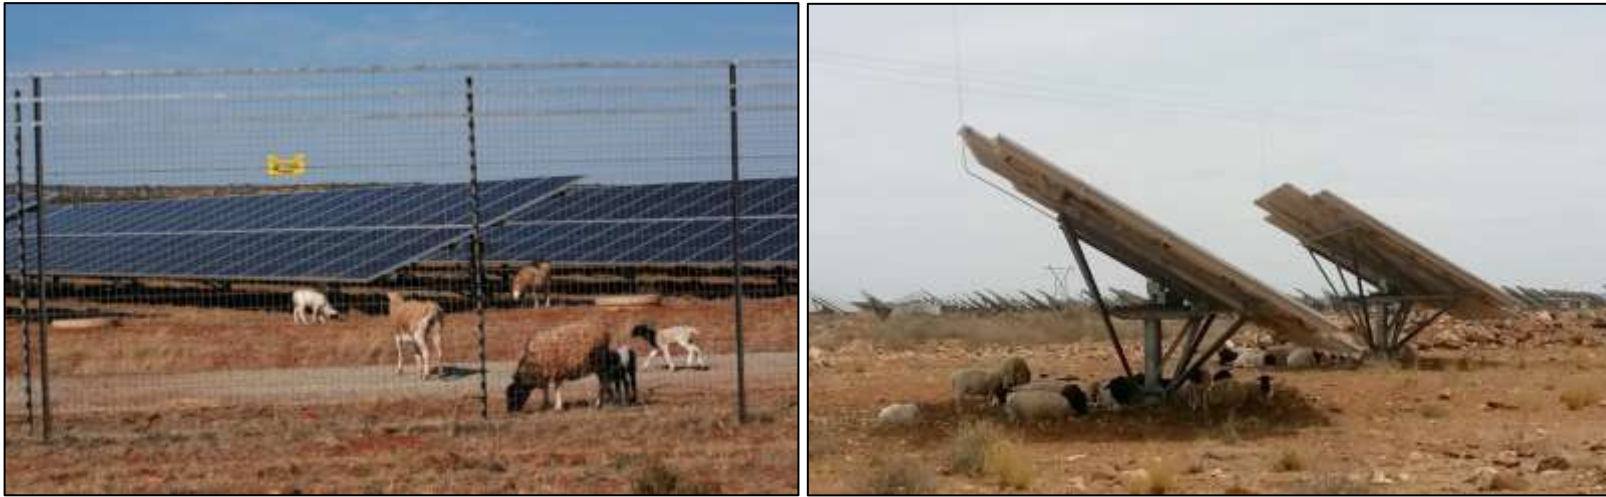
Figure 13. Sheep grazing within different PV plants in the Northern Cape.

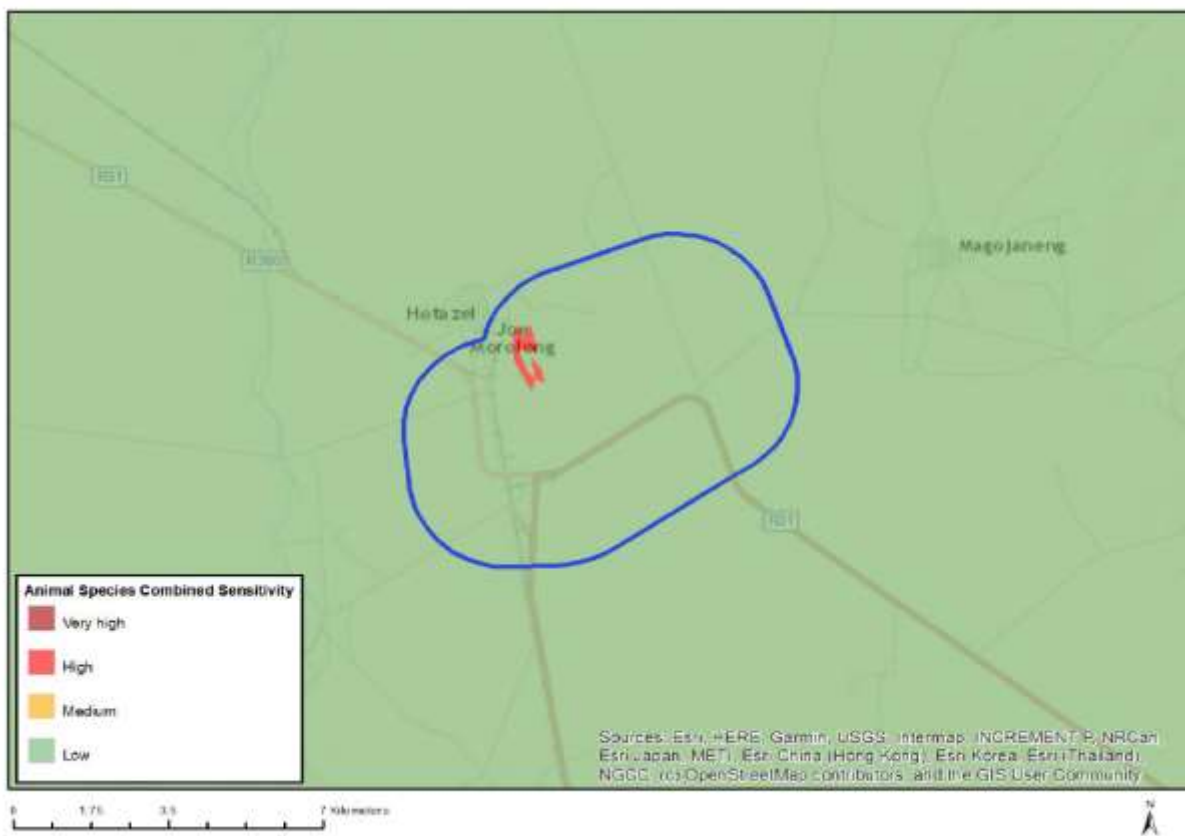
Animal Species Theme

The relative animal species theme sensitivity is provided below and indicates that the site does not fall within the known or modelled range of any terrestrial animal species of high conservation concern. There is a small high sensitivity area around Hotazel, but this is due to the potential presence of Verreaux's Eagle which is outside the scope of this study.

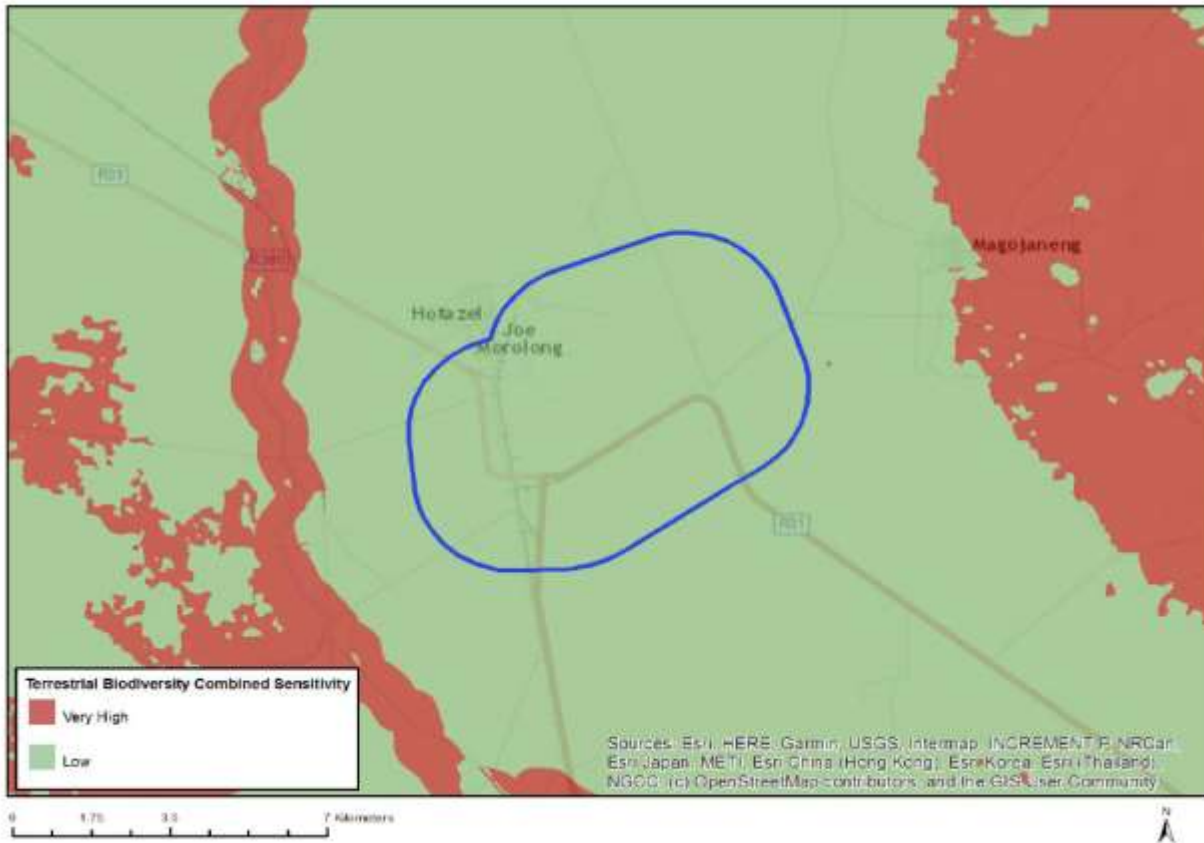
Terrestrial Biodiversity Theme Sensitivity

The terrestrial biodiversity theme sensitivity map is illustrated below. There are no sensitive features within or near the development site.
