Milfoil Eradication by Diver Hand Pulling in Walsh Lake, Washington

Rob Zisette and Josh Wozniak

Herrera Environmental Consultants, Seattle, WA

Seattle's Unfiltered Water Supply from Upper Cedar River Watershed

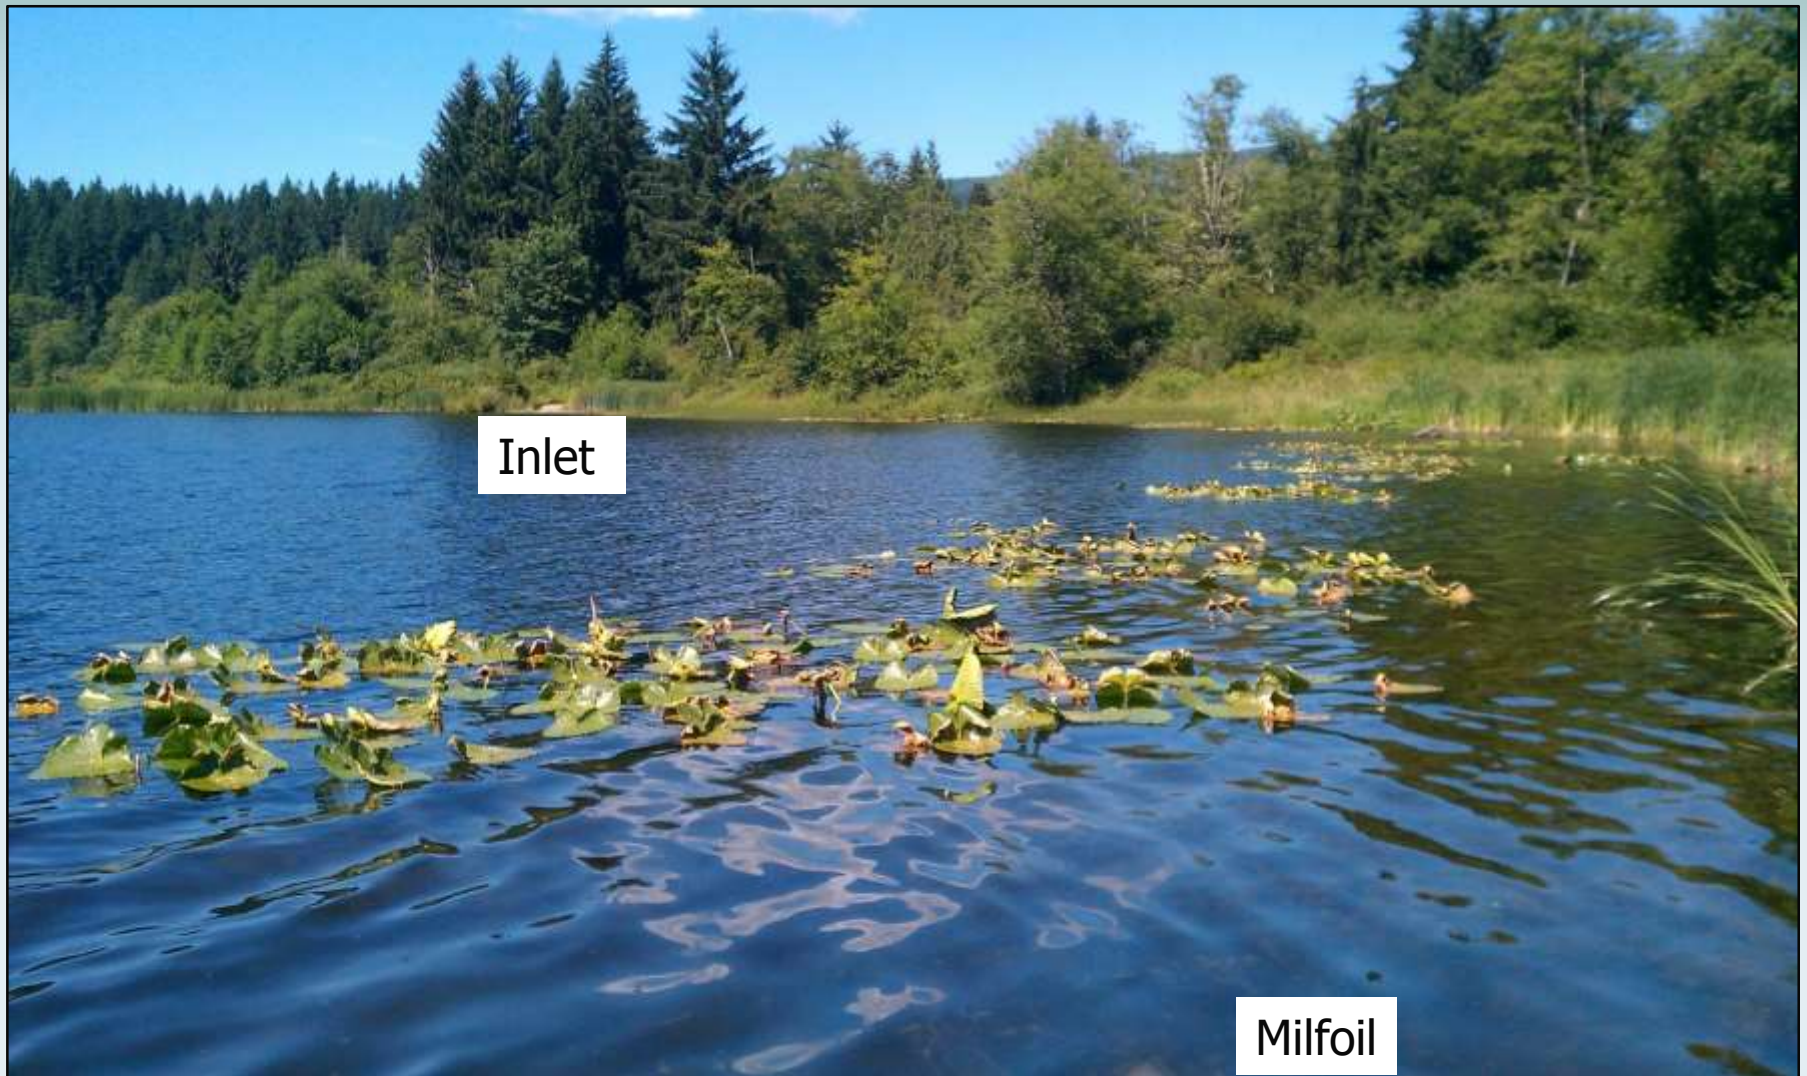
Milfoil Core 540 Feet South of Inlet

Inlet

Milfoil

Fisherman Vector

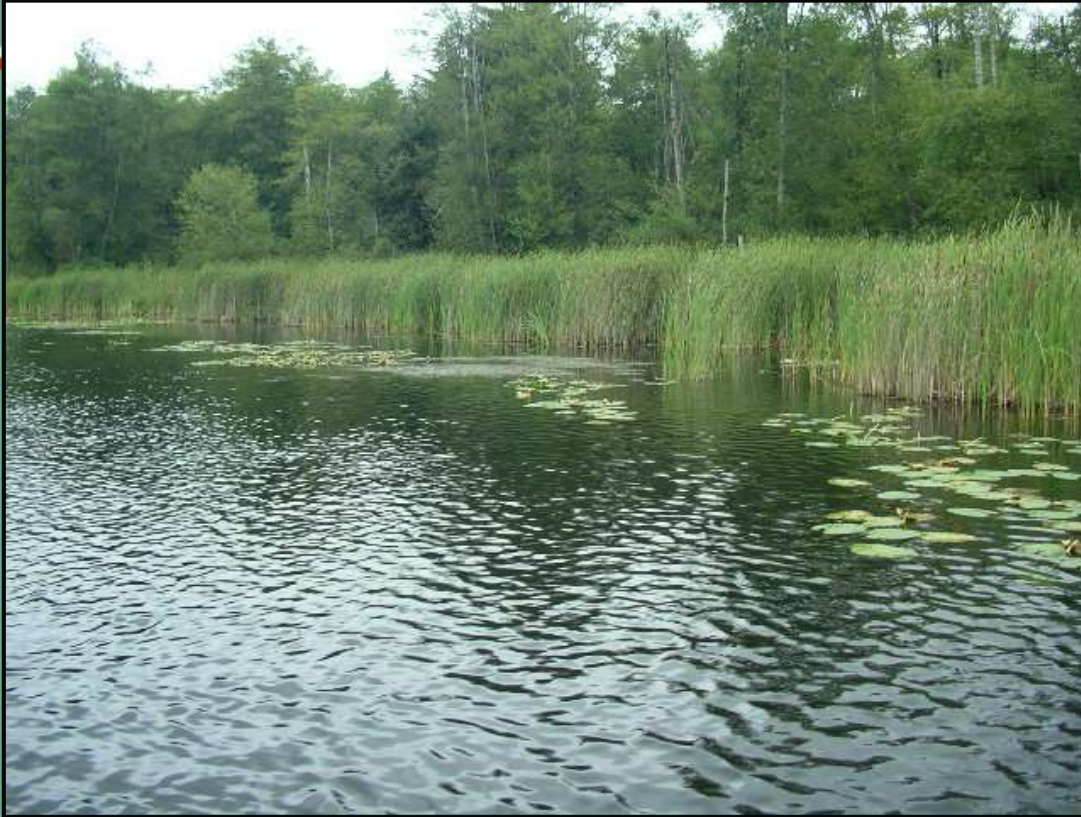
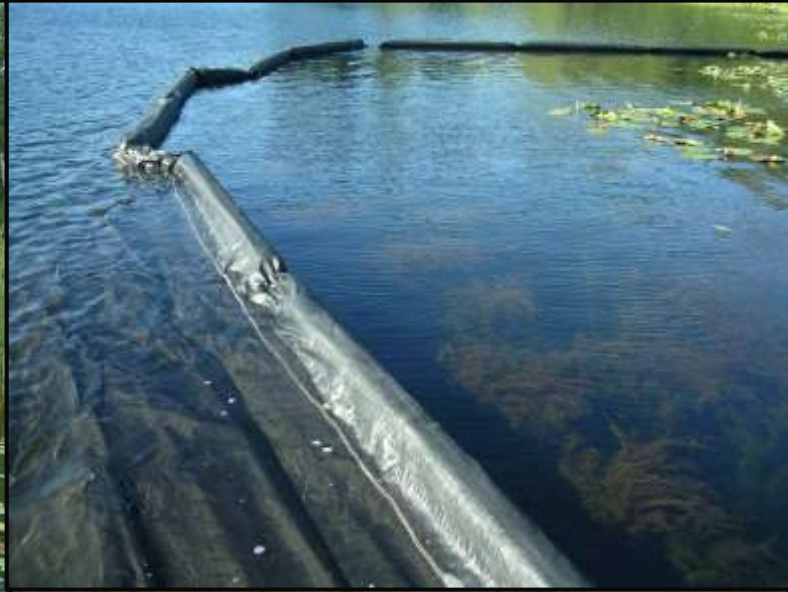
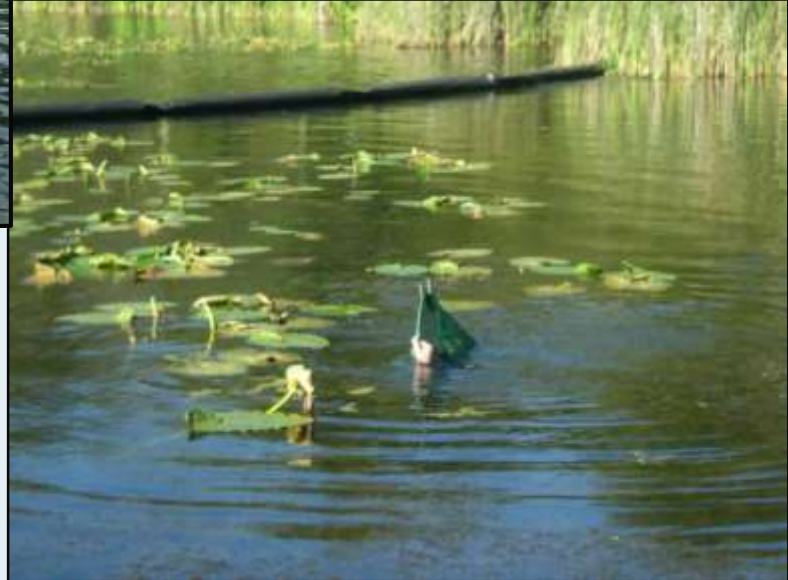
2005 Milfoil Control Approach

1. Pull milfoil outside dense milfoil core
2. Install curtain around core
3. Pull milfoil inside/outside of curtain

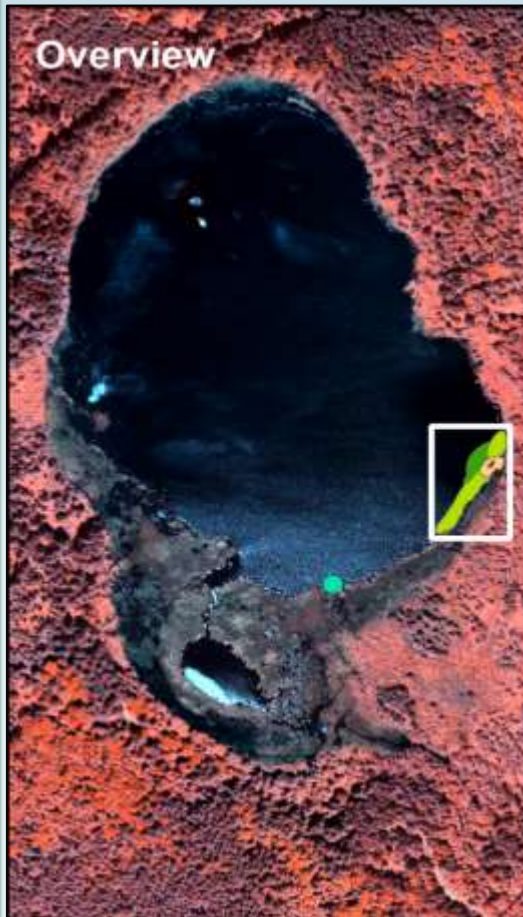
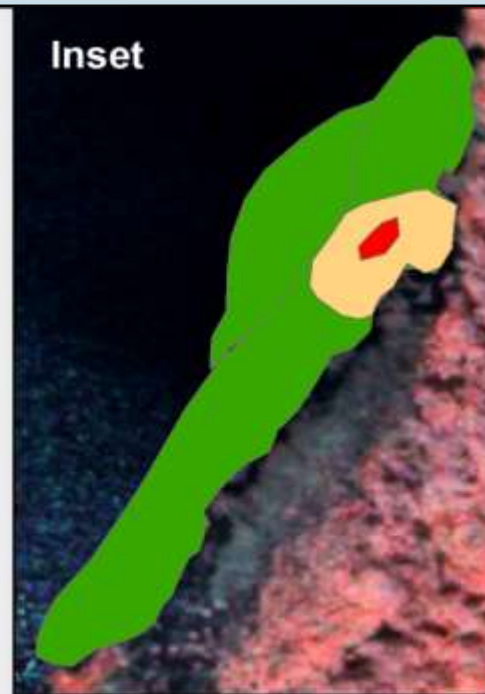
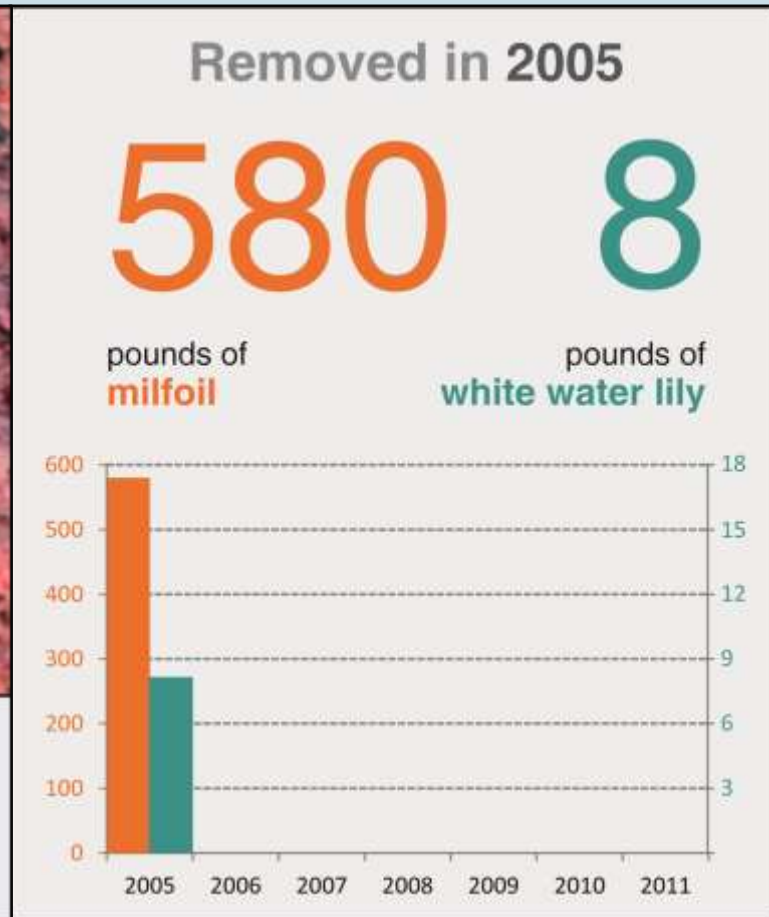
2005 Survey and Removal

- Low density milfoil
- High density milfoil
- Containment area

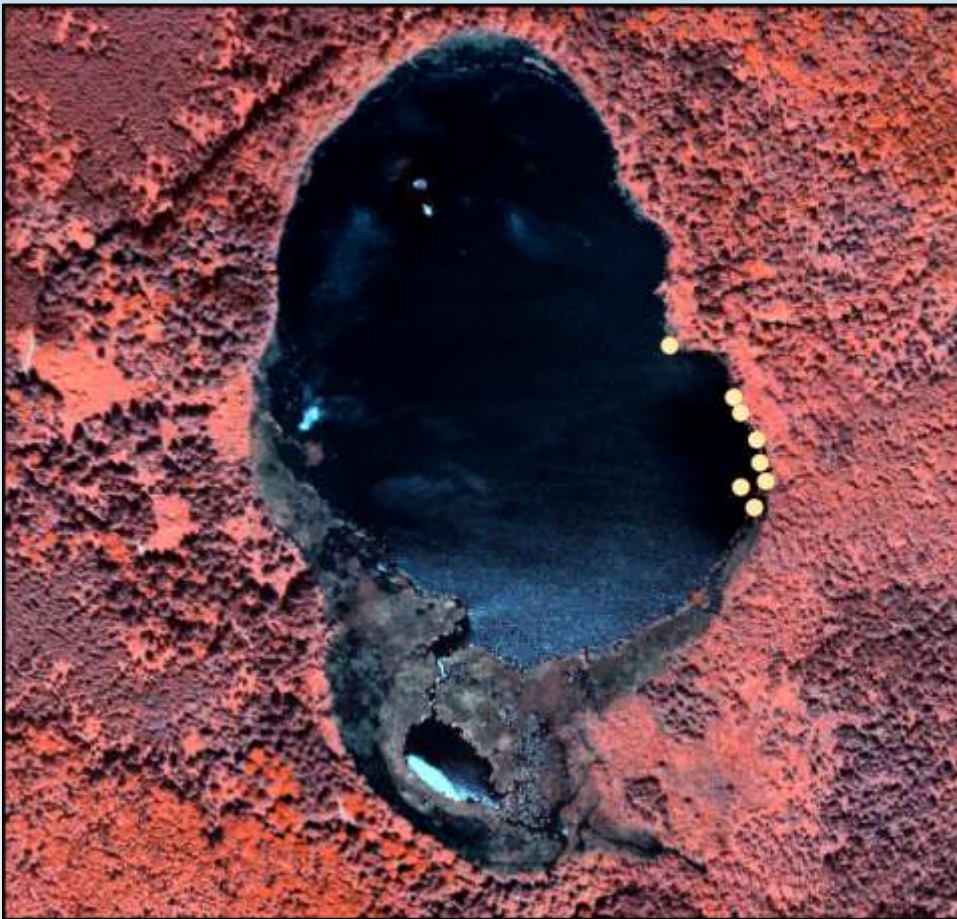
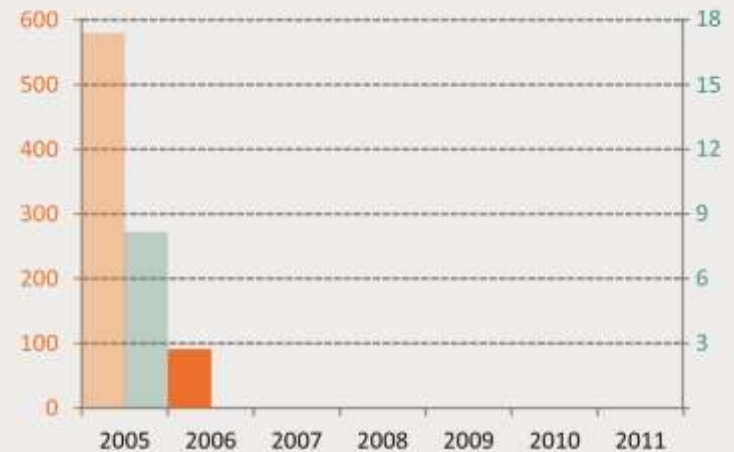
2006 Survey and Removal

Removed in 2006

91

pounds of
milfoil

0

pounds of
white water lily

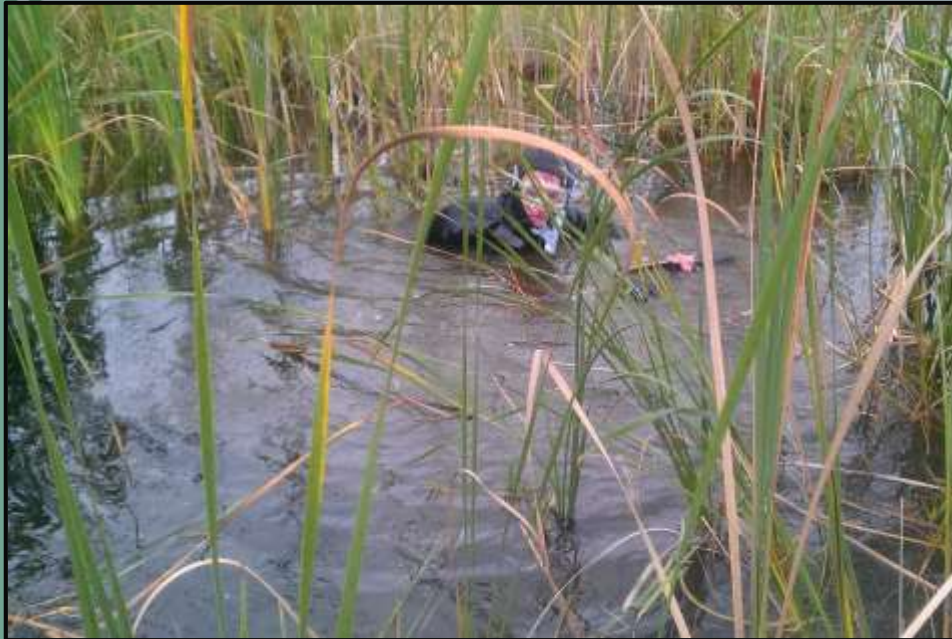
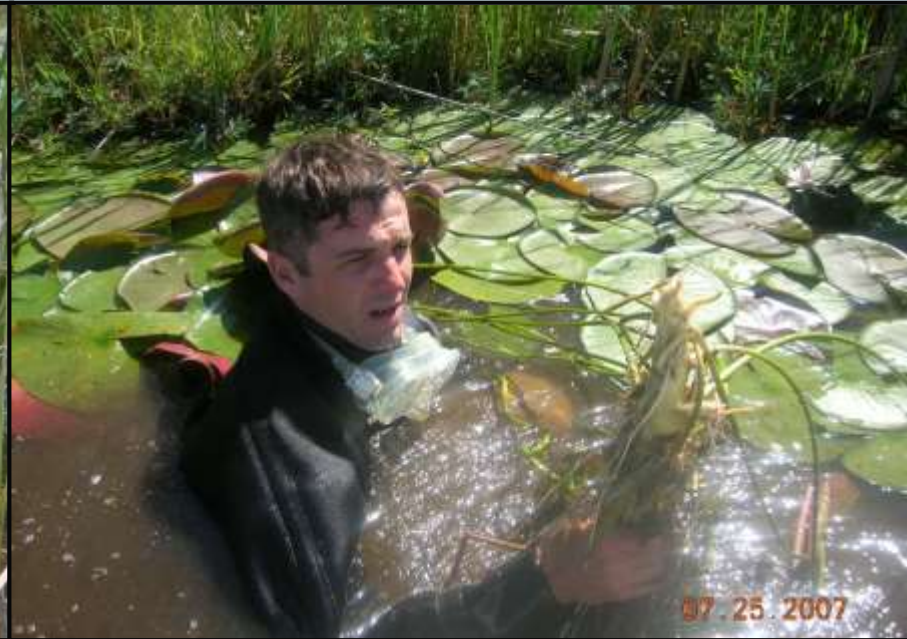
2007 Expanded Search and Control

Expanded search deep within cattails
Found milfoil at beaver dam outlet

Hand pulling water lily patch

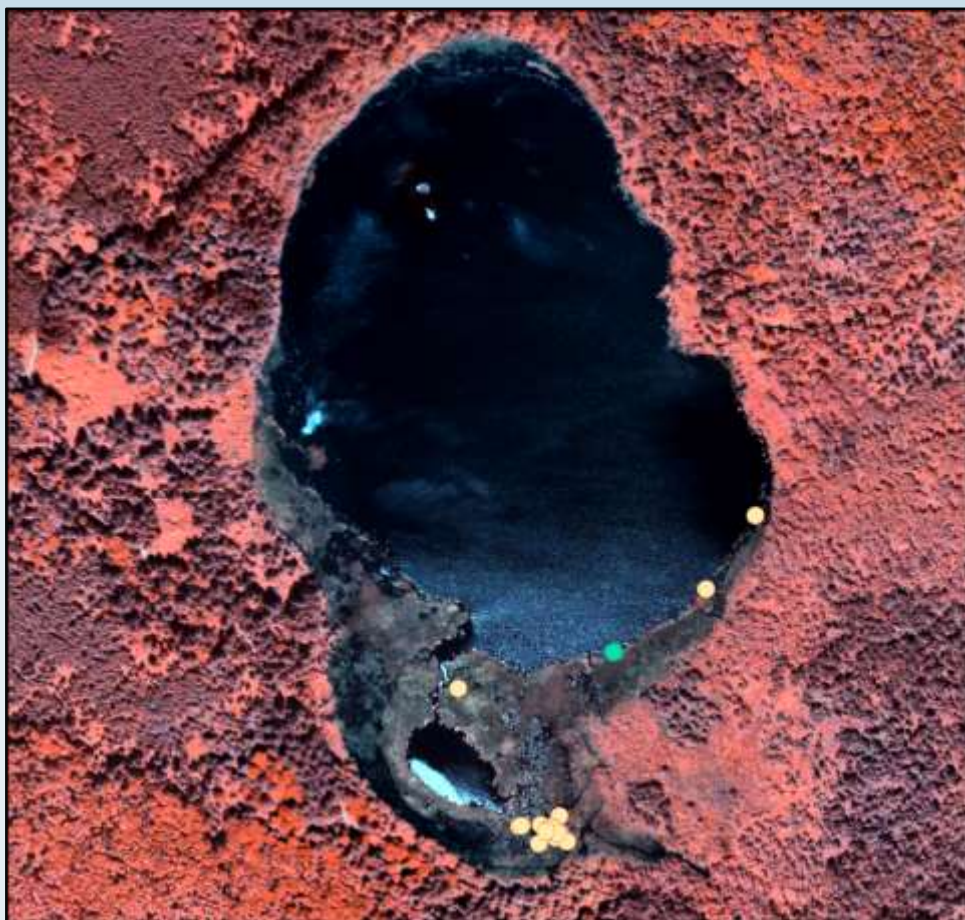
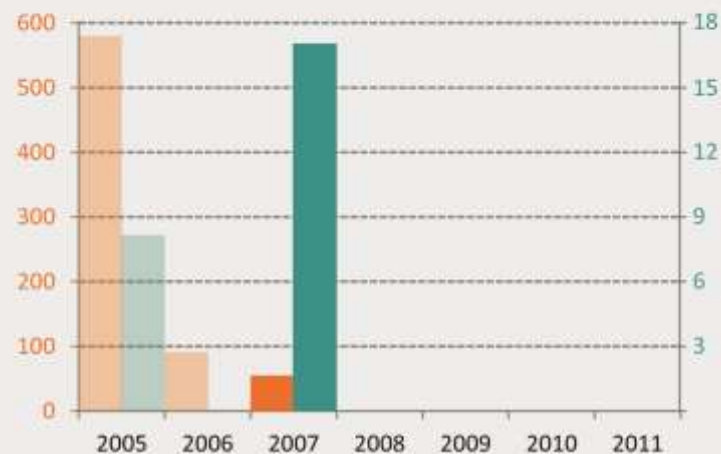
2007 Survey and Removal

New milfoil site at outlet dam built by beaver vector

Removed in 2007

55

pounds of
milfoil

17

pounds of
white water lily

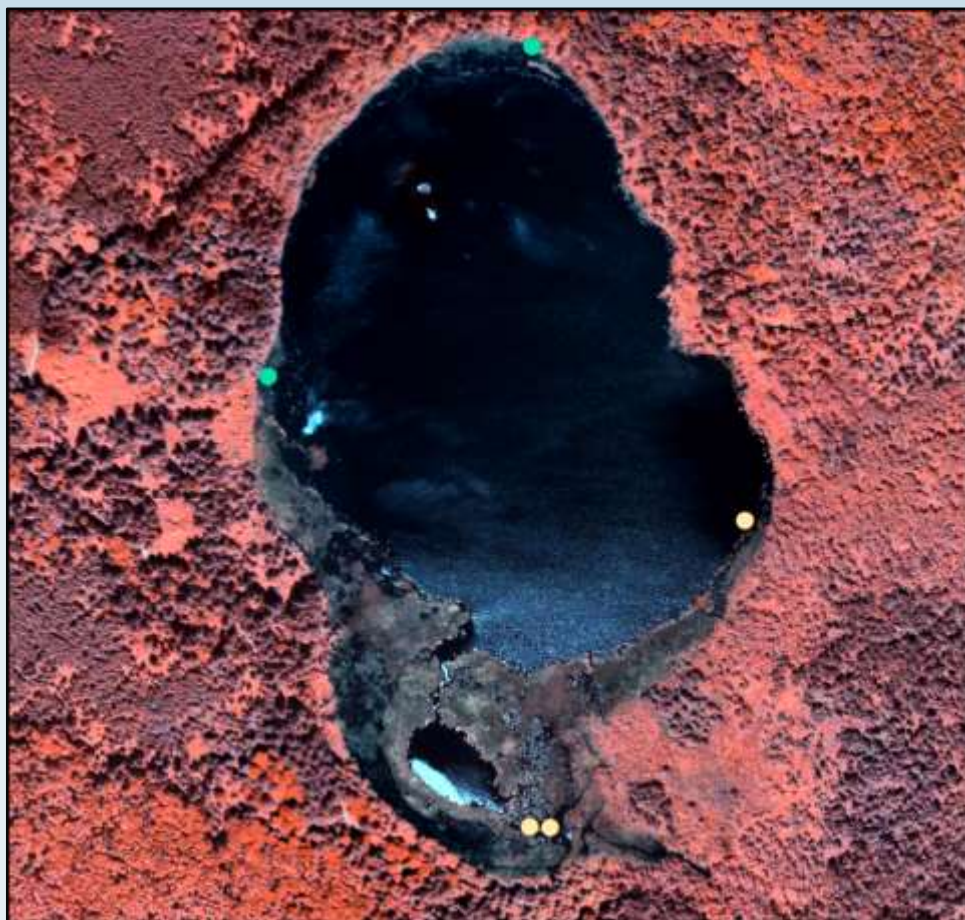
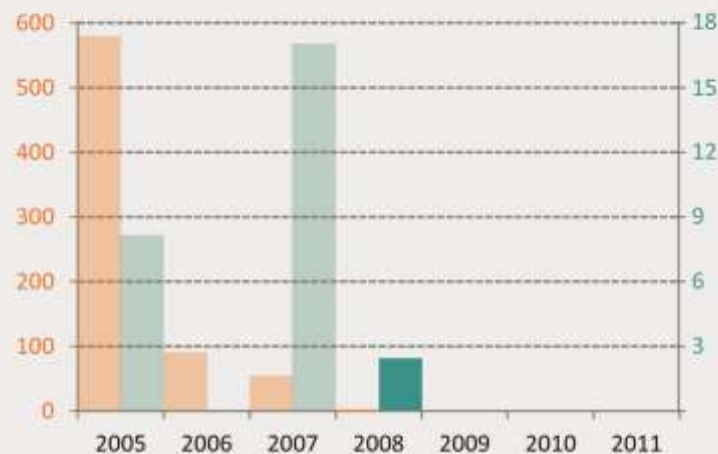
2008 Survey and Removal

Removed curtain and laid small bottom barrier
Two new lily patches

Removed in 2008

0.2 2.5

pounds of
milfoil

pounds of
white water lily

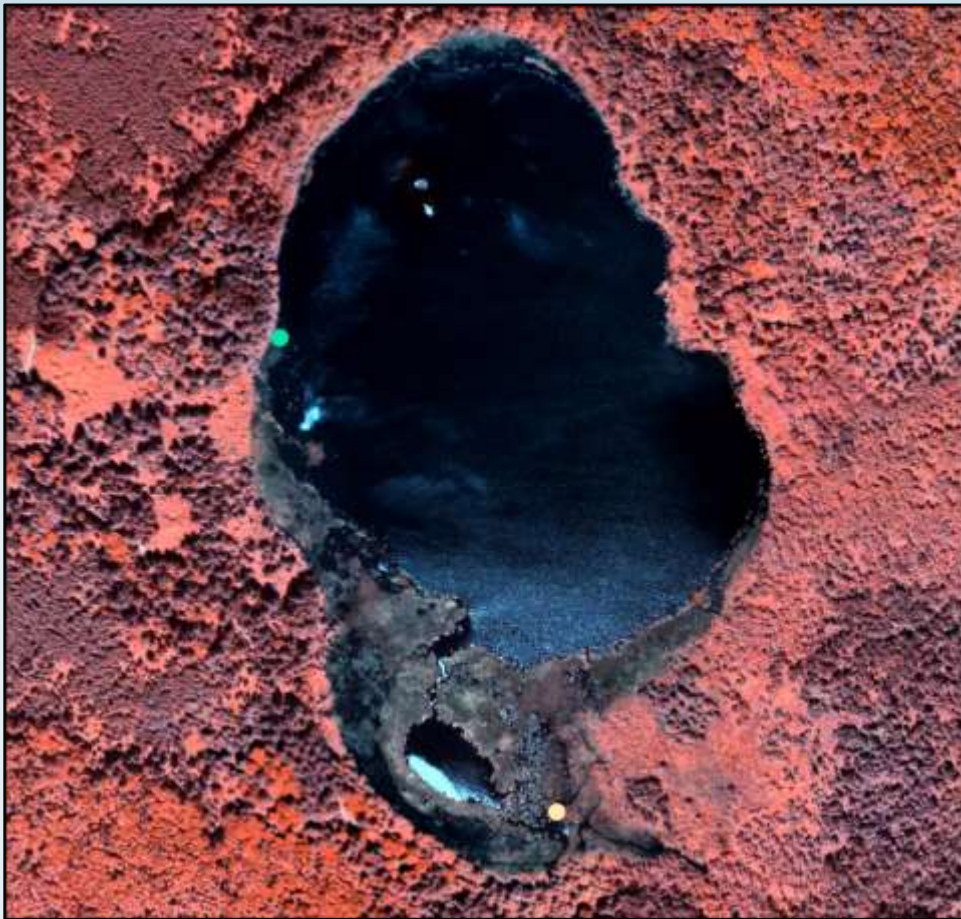
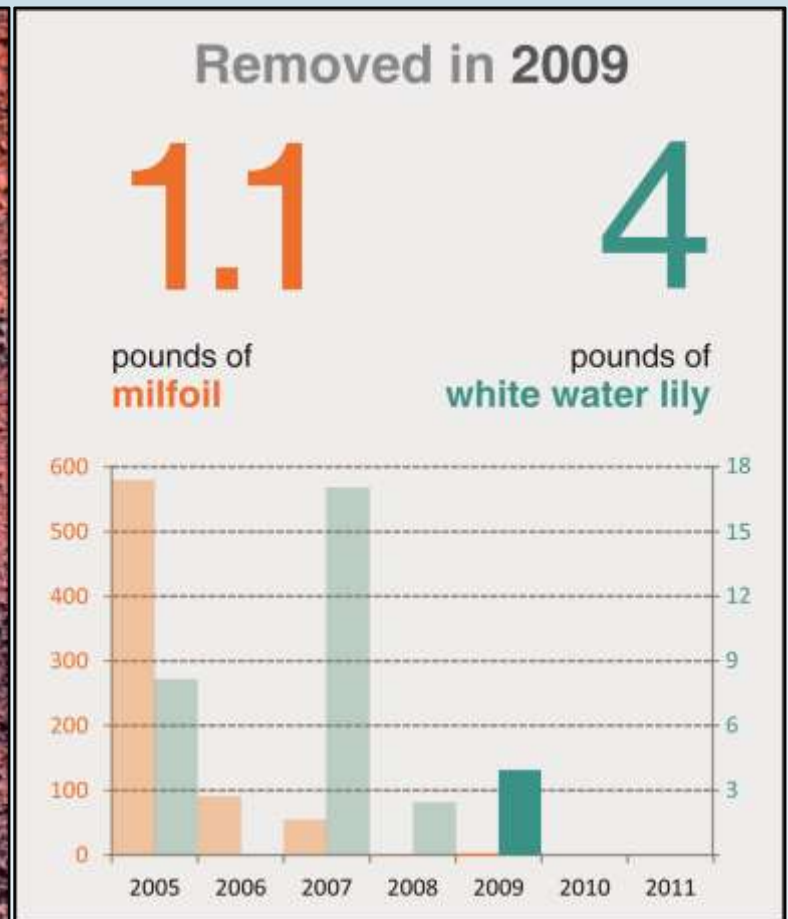
2009 Survey and Removal

Small amounts of milfoil and lily removed

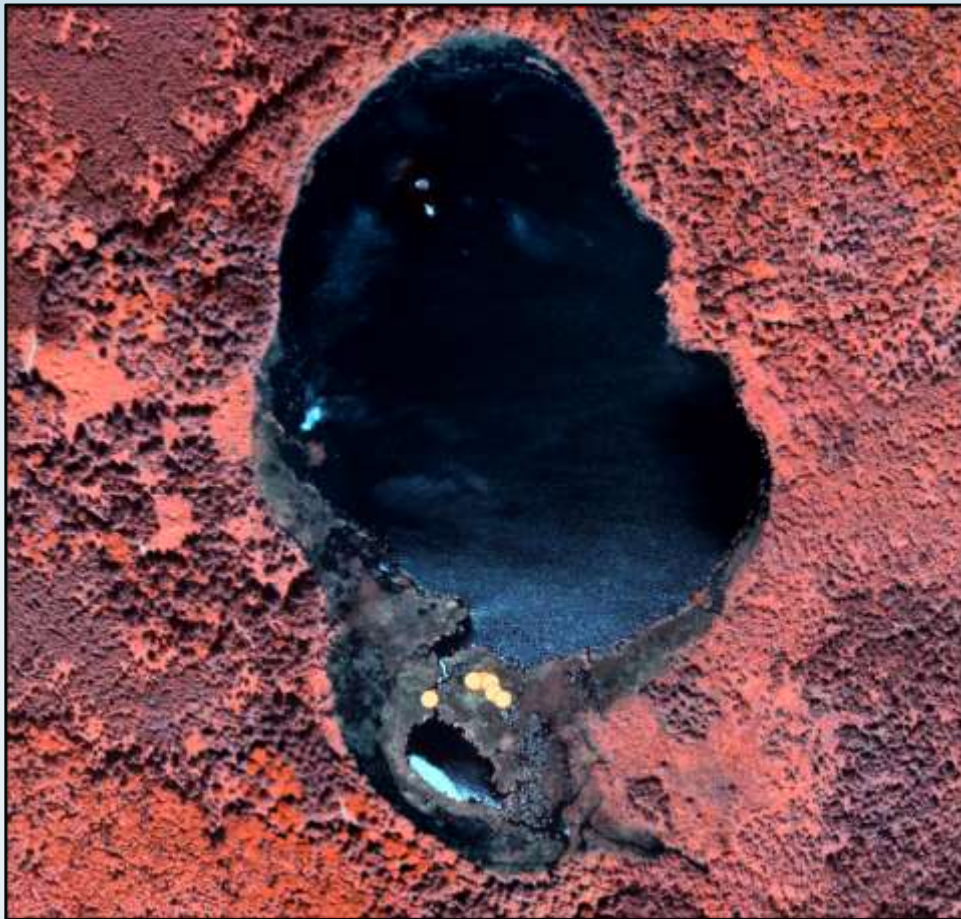
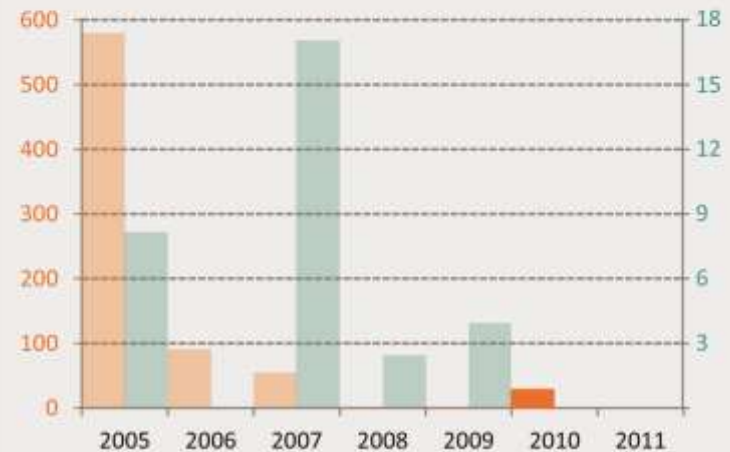
2010 Survey and Removal

Removed in 2010

28

pounds of
milfoil

0

pounds of
white water lily

New milfoil site in cattails by beaver lodge

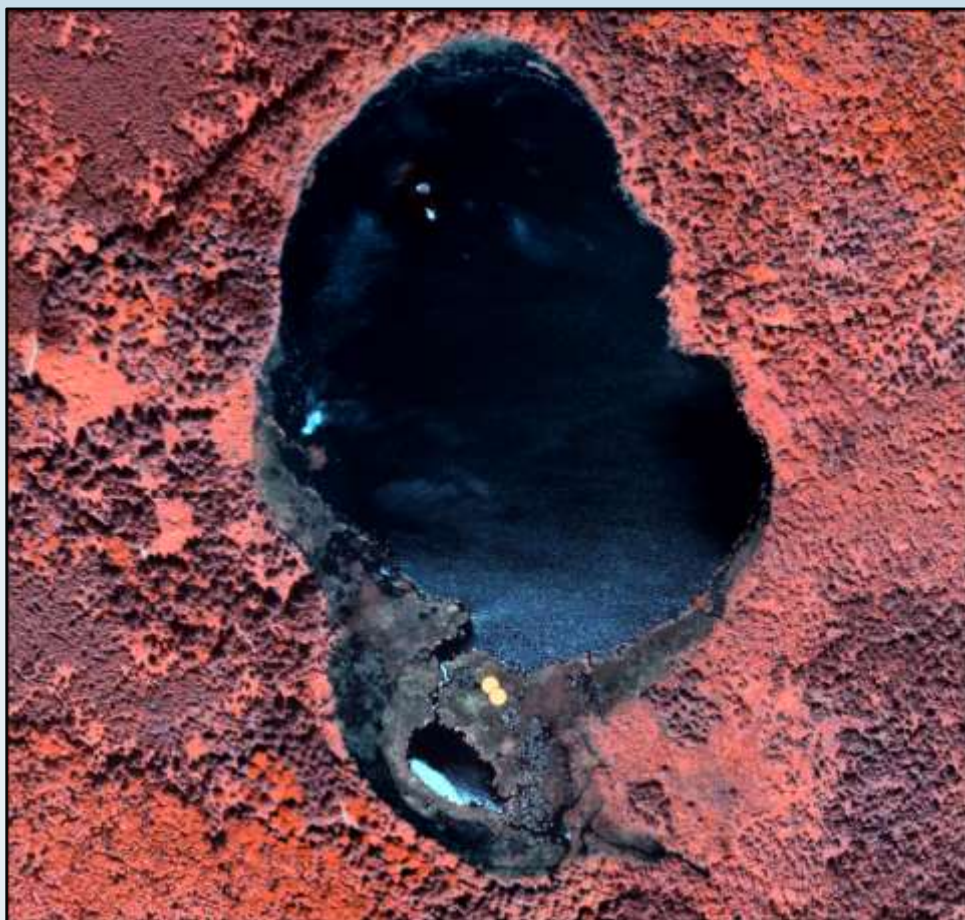
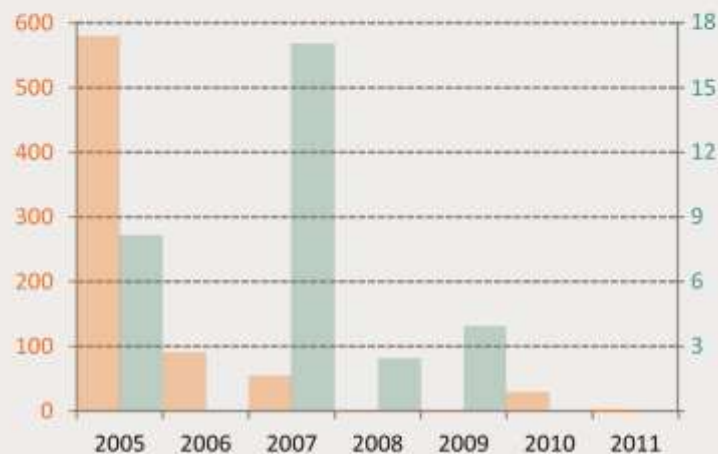
2011 Survey and Removal

Only 8 short milfoil plants in cattails by beaver lodge

Removed in 2011

0.5

pounds of
milfoil

0

pounds of
white water lily

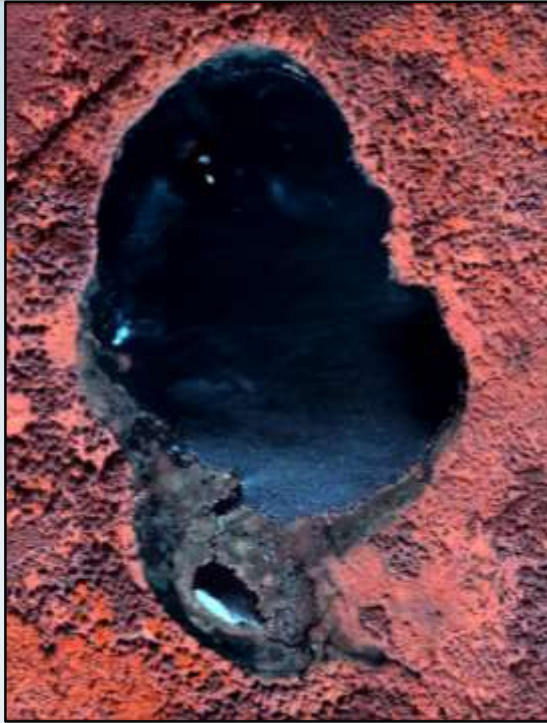
2012 (3 Days)
No milfoil
No water lily

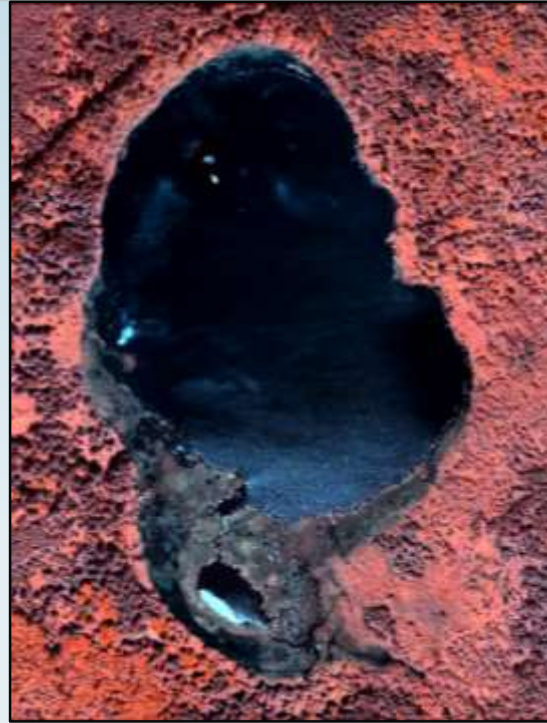
2013 (1 Day)
No milfoil
No water lily

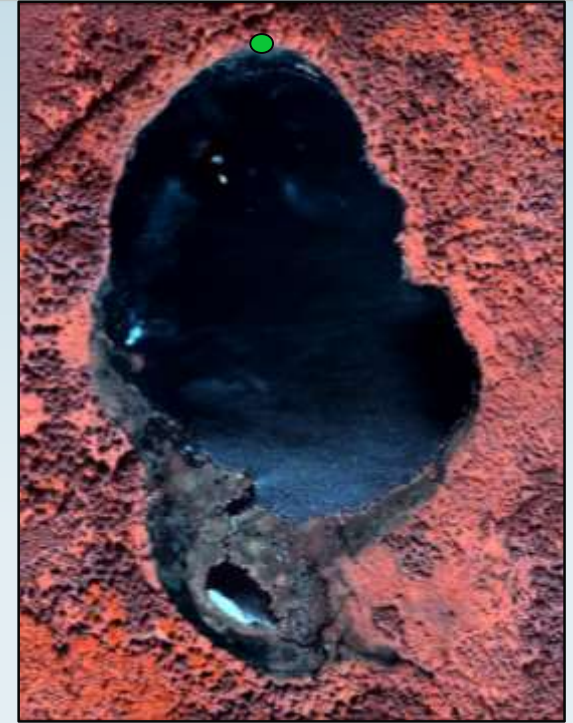
2014 (1 Day)
No milfoil
One water lily
