Independent Environmental Impact Assessment for the Upgraded Kamuzu Barrage

Final Environmental and Social Impact Assessment Volume 2: Technical Reports

December 2013

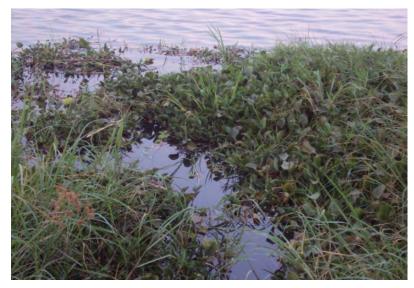
Figure 15. Water hyacinth plants in the Shire River (Photo: F. Kapute)

Water hyacinth and other aquatic weeds continue to cause serious problems to power generation at Nkula Hydro Electric Power Station (the first HEP Station downstream of Kamuzu Barrage) by blocking the screens at the inlet to the turbines (Mzuza, 2010; Liabunya, 2007; Chapalapata, 2007).

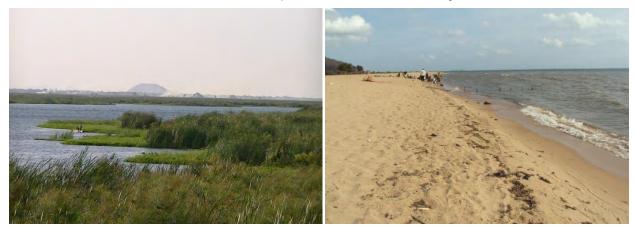
Figure 35. Shire River (L) and Lake Malawi (R) marshy and sandy shorelines respectively (Photos: F. Kapute)

The shoreline for the Shire River system as observed during the field survey is generally covered by vegetation all the way from the outflow point of Lake Malawi (Figure 35L). This is different from Lake Malawi, where the shoreline has clear and sometimes wide sandy beaches (Figure 35R). Breeding of the cichlid fishes that make nests and spawn their eggs along the sandy beaches is therefore more pronounced in Lake Malawi than in the Shire River. The latter favours riverine species more than all cichlids in general.
