FINAL BASIC ENVIRONMENTAL ASSESSMENT

Basic Environmental Assessment
for the Construction of a lodge and
additional staff accommodation,
Lion Sands, Sabi Sand Game
Reserve

Ref. No: 17/2/3/E-257

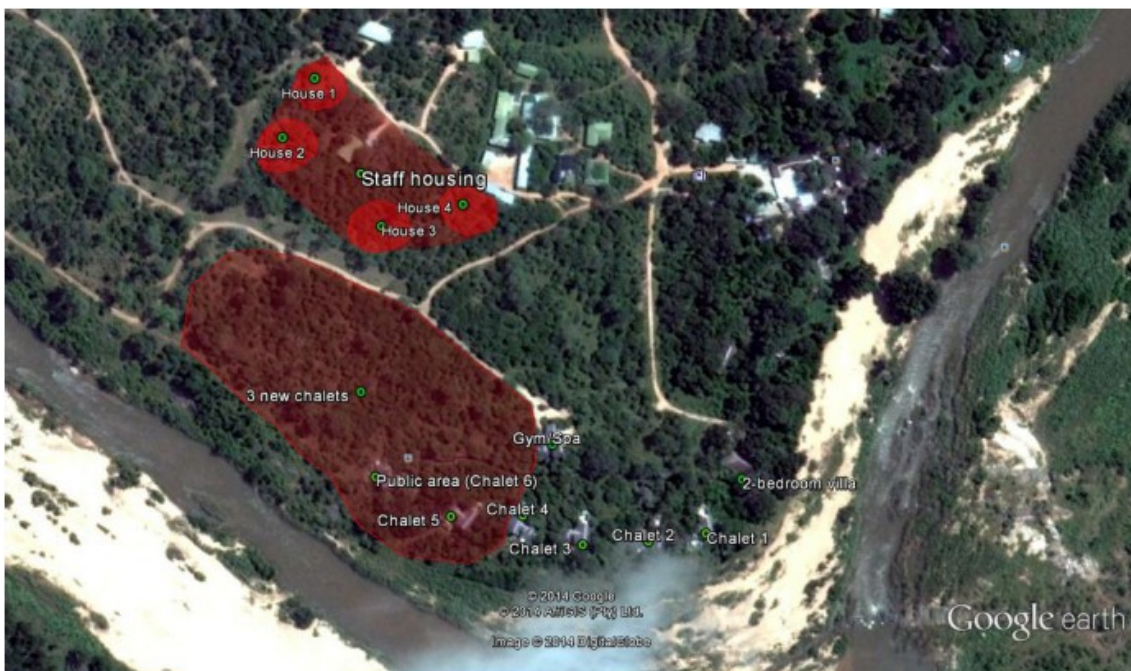
It is proposed that the existing reception area and curio shop is to be converted into a gym and spa (Figure 2). This facility will allow for an increased range of activities made available to the paying guest and will ultimately contribute to their experience. This developmental activity does not require authorisation as it entails solely the internal refurbishments of the existing infrastructure.

Figure 2: Satellite image indicating the locations of the existing buildings to be modified and the sites where the proposed new developments are to occur (Source: Google Earth 2014).

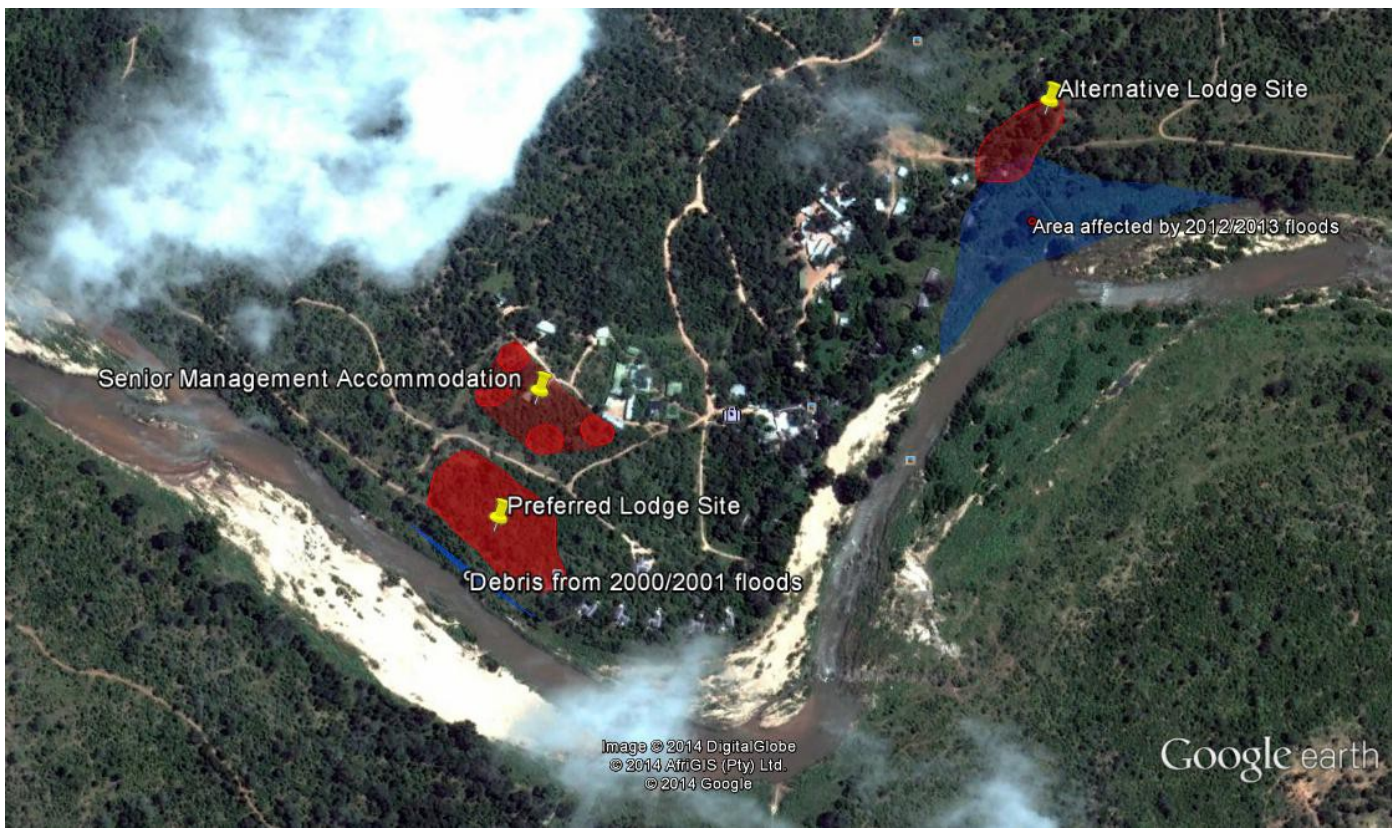
There are four identified sites within the demarcated area for the development of a new staff house as illustrated in Figure 4. Various parameters associated with environmental risks and

Figure 4: Location of the preferred lodge site, alternative lodge site and staff accommodation (Source: Google Earth 2014).

It should be noted that all the structures and proposed new developments mentioned above are outside of the known flood lines (2012, 2013 and 2014 floods were well below these areas) (Figure 4). The flooding potential thus appears to be small and has not been considered in great detail here, although the potential was included in the assessment tables in section 12.

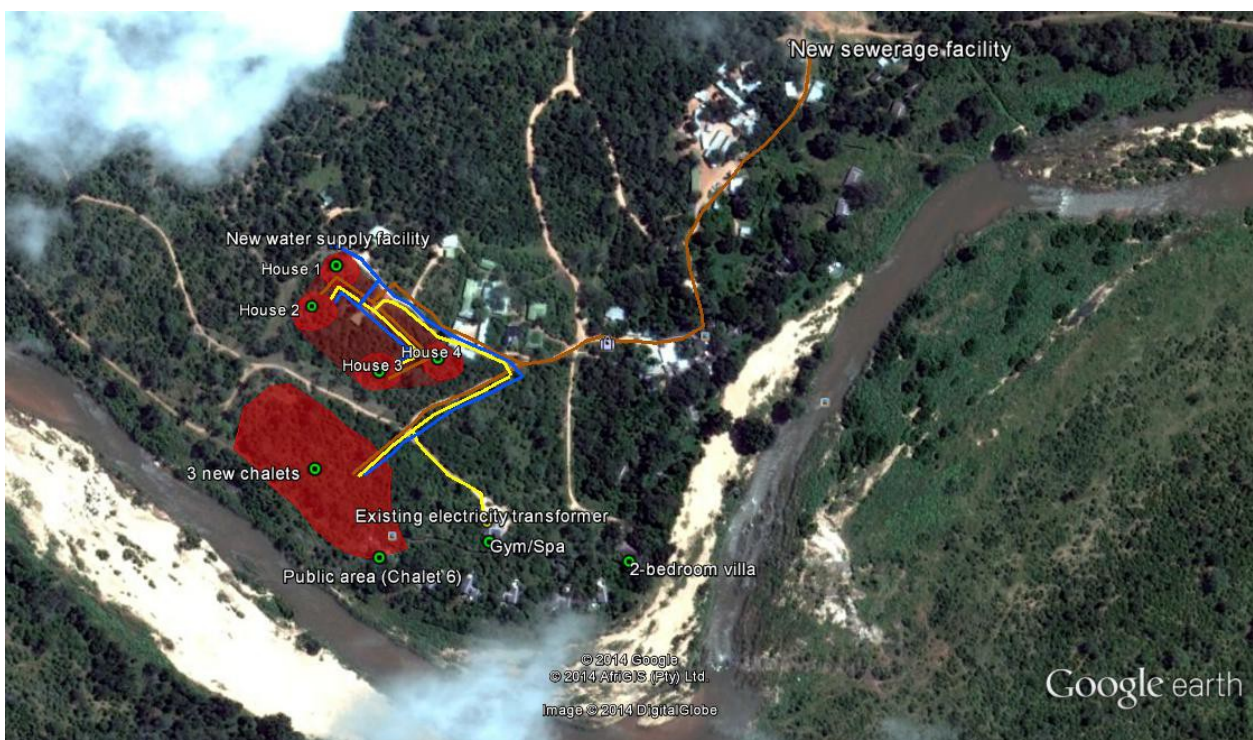
Electricity will be supplied to each of the proposed developments from the existing supply point (transformer) (Figure 5). A new water treatment and supply facility is planned to be constructed to replace the existing 'Jojo tanks'. This new facility is to be located in close proximity to the demarcated area for the new staff house. A new sewerage facility (above ground package plant) has been recently installed in the north-eastern section of the lodge.

Figure 5 illustrates the potential route which each utility service would follow in order to link up with the existing services (Note: The exact location of the three new chalets is currently being assessed using the ecological data; therefore the probable route each utility service will follow has been sketched to terminate within the demarcated area for the proposed development).

Figure 5: Potential electricity (yellow), water (blue) and sewage (brown) utility routes which link to the developmental sites (Source: Google Earth 2014).

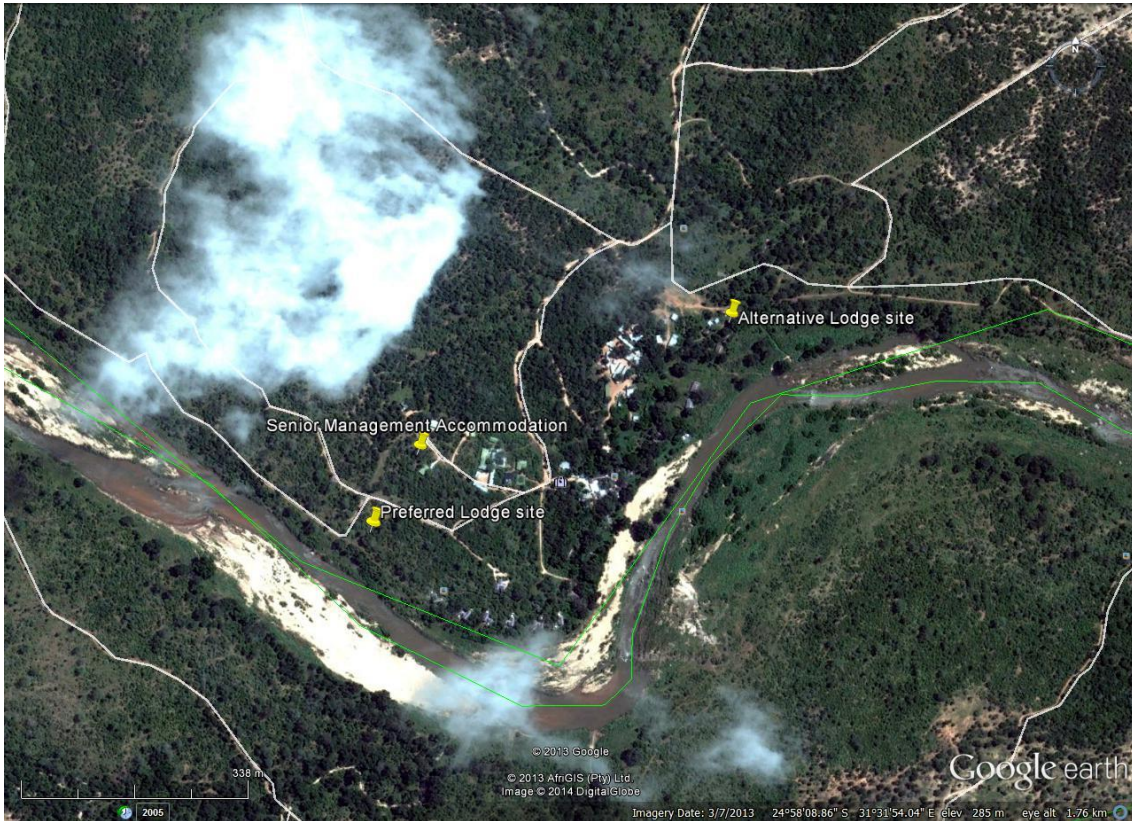
Figure 1: Satellite image indicating the location of the various proposed activities.

The proposed development is in essence an extension of the existing Lion Sands River Lodge complex. There are two proposed sites for the new lodge (*Figure 1*). The preferred site is an un-impacted area to the west of the existing lodge, following the river bank (*Figure 2*). The alternative site would involve the demolition of some staff housing and to construct the units on the exiting footprint and extending it across a small drainage line (involving a walkway across this drainage line to connect the accommodation units) (*Figure 3*).

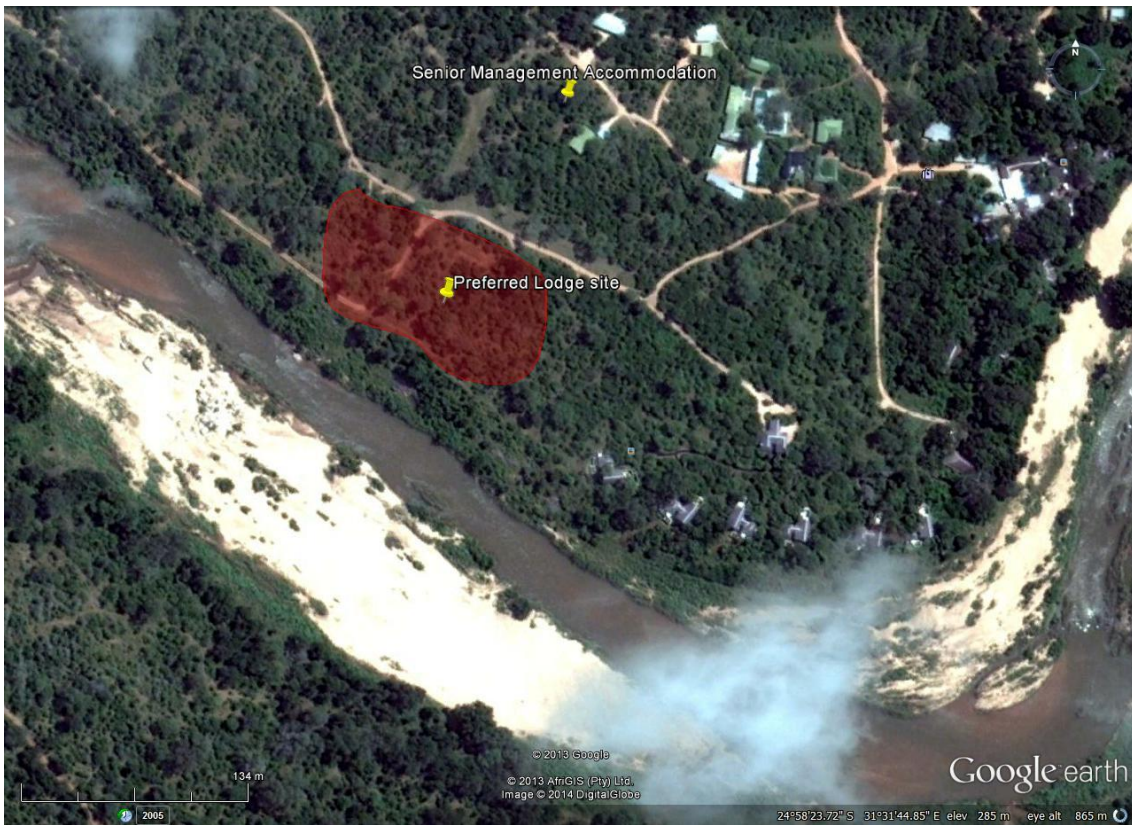
Figure 2: Satellite image indicating the preferred site for Lodge Expansion.

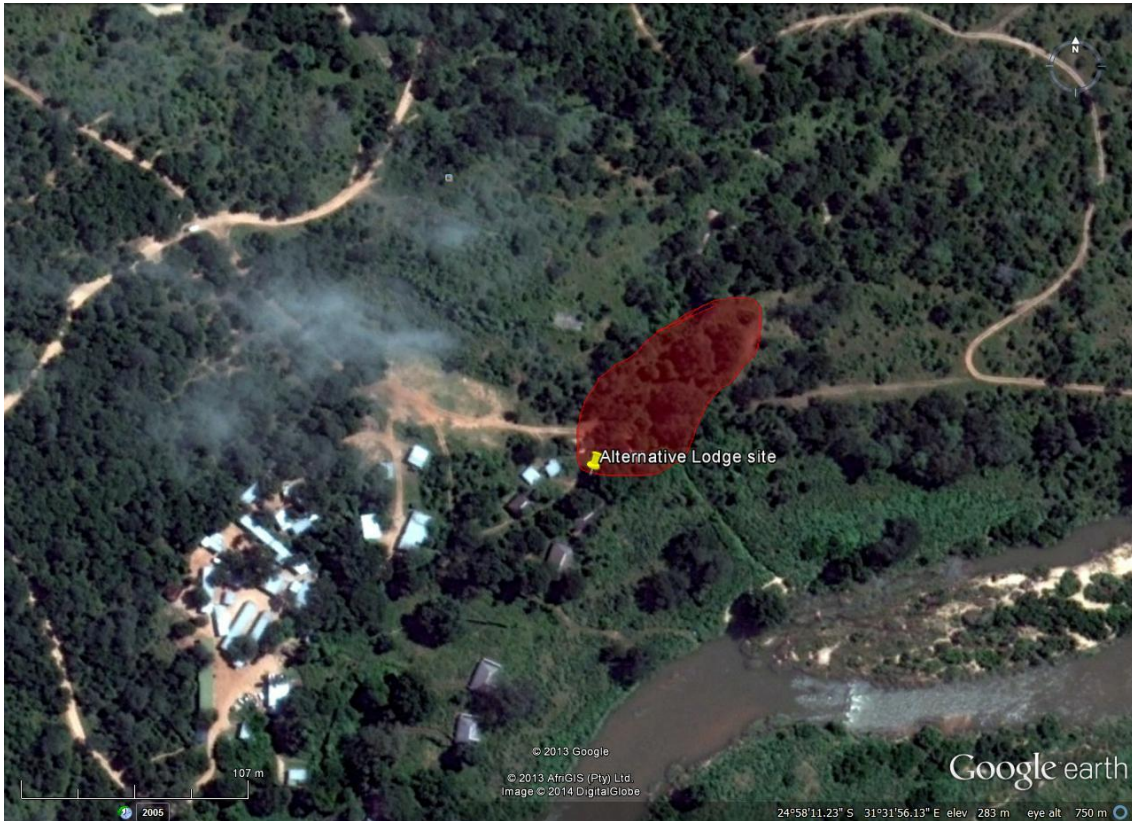
Figure 3: Satellite image indicating the alternative site for Lodge Expansion.

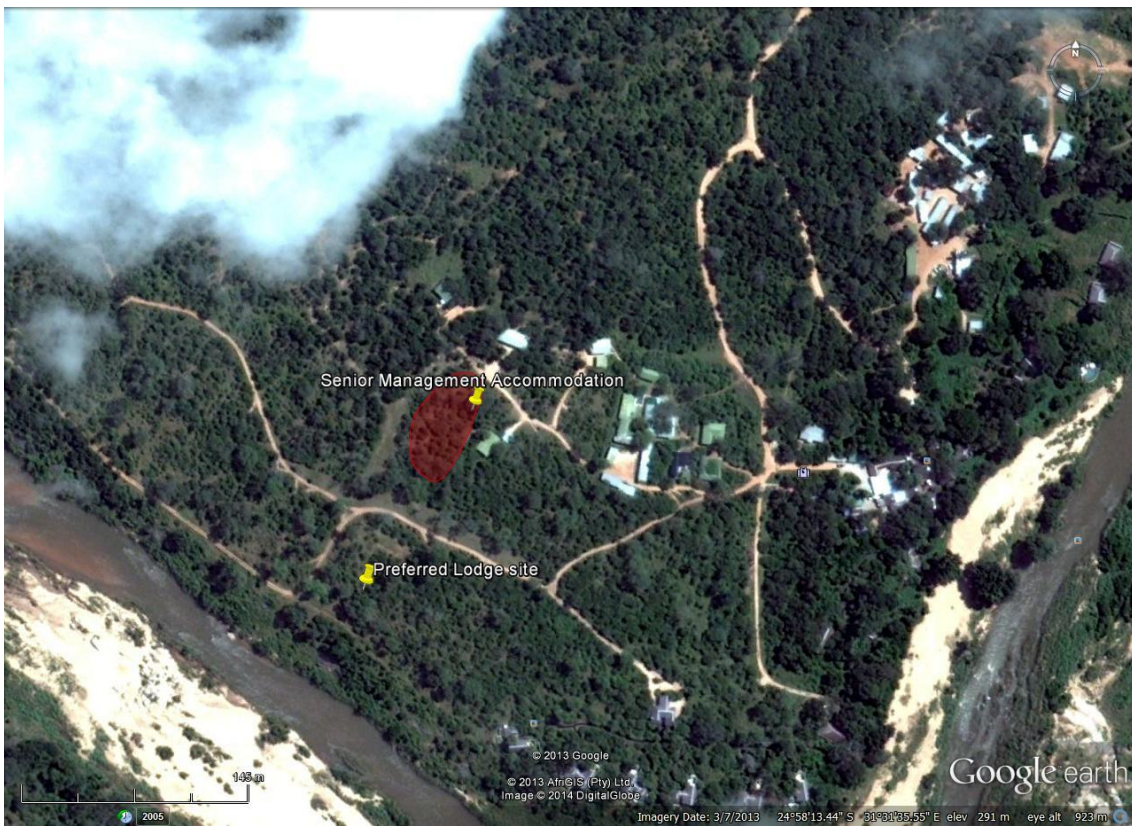
Figure 4: Satellite Image indicating location of the proposed Senior Staff Accommodation.

With the potential demolition of the senior management houses on the alternative site of the proposed lodge development, it is proposed to construct additional senior staff accommodation units of 80-100m². It is proposed that these units are located near the existing senior staff accommodation (*Figure 4*).

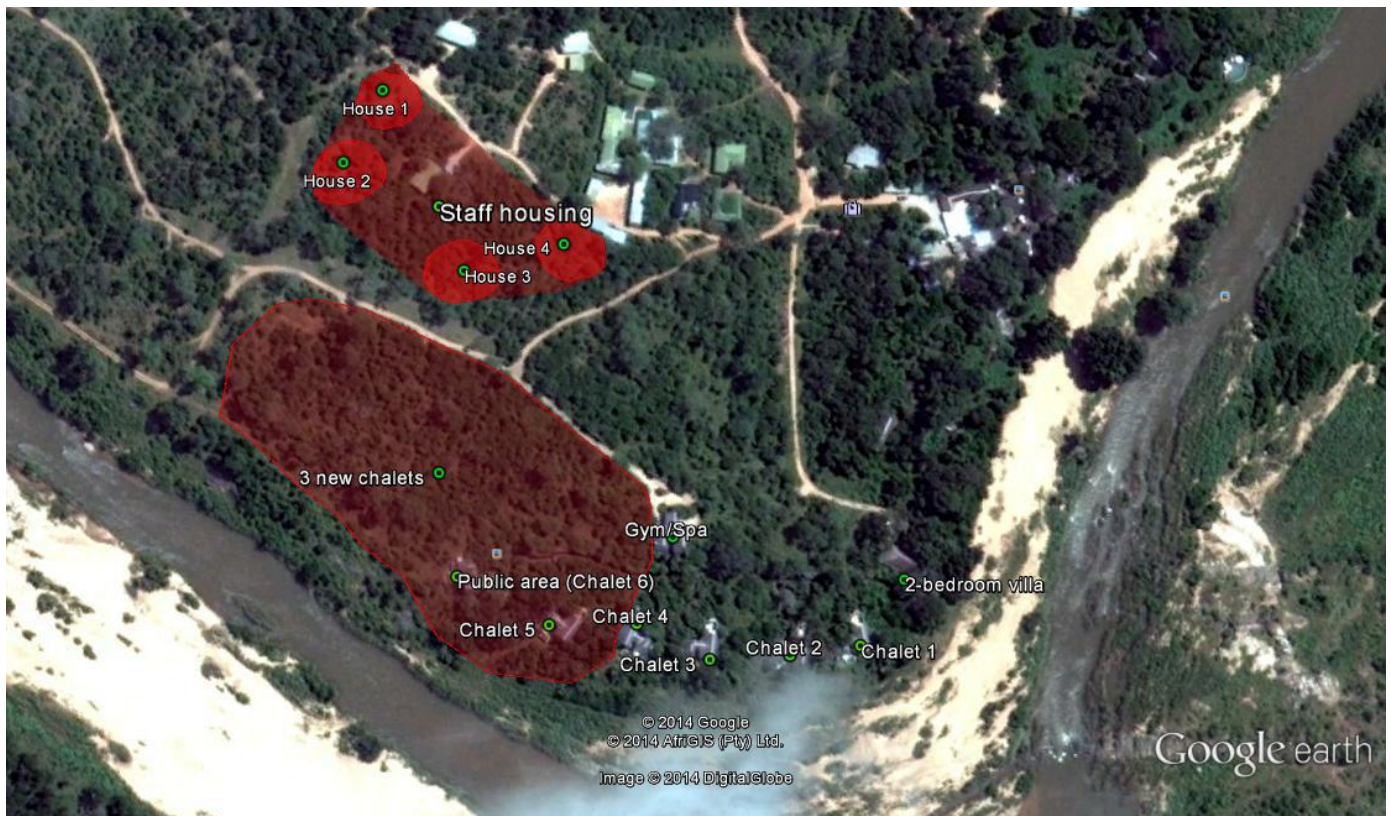
Figure 1: Location of the field survey area at the Lion Sands Ivory Lodge (Source: Google Earth 2014).

An ecological assessment was conducted within the demarcated areas shown in Figure 1 below. Cardinal photographs of each of the proposed potential developmental sites are provided in Appendix 3 of the Basic Assessment Report.

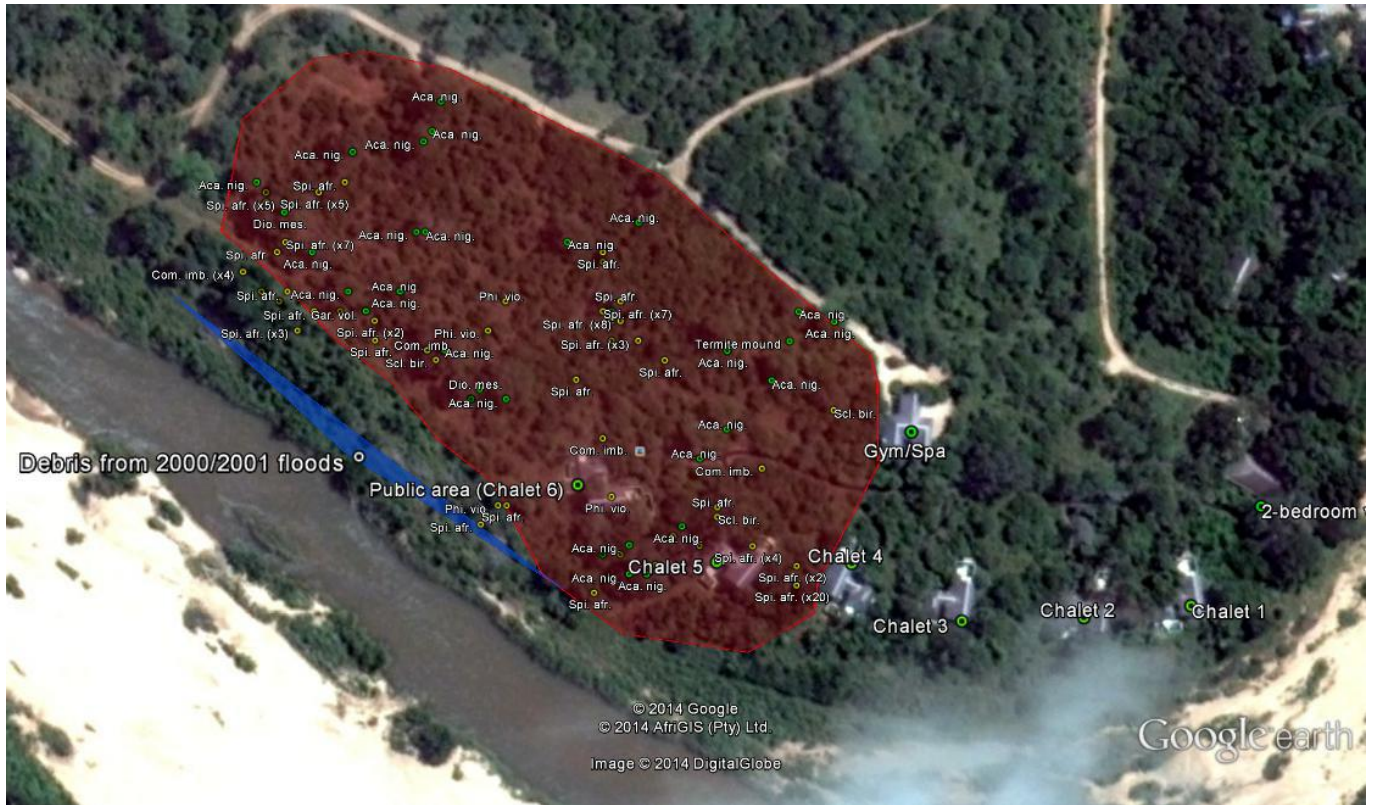
Figure 3: Visual representation and location of protected trees and significant ecosystem components within footprint of the potential developmental site (Source: Google Earth 2014).

Note: Trees marked with a yellow marker are protected and trees marked with a green marker are large trees which should be avoided during the construction process. Due to the scale of the image some trees are not displayed in the illustration. Refer to Table 2 above for all significant georeferenced trees occurring within the study area.

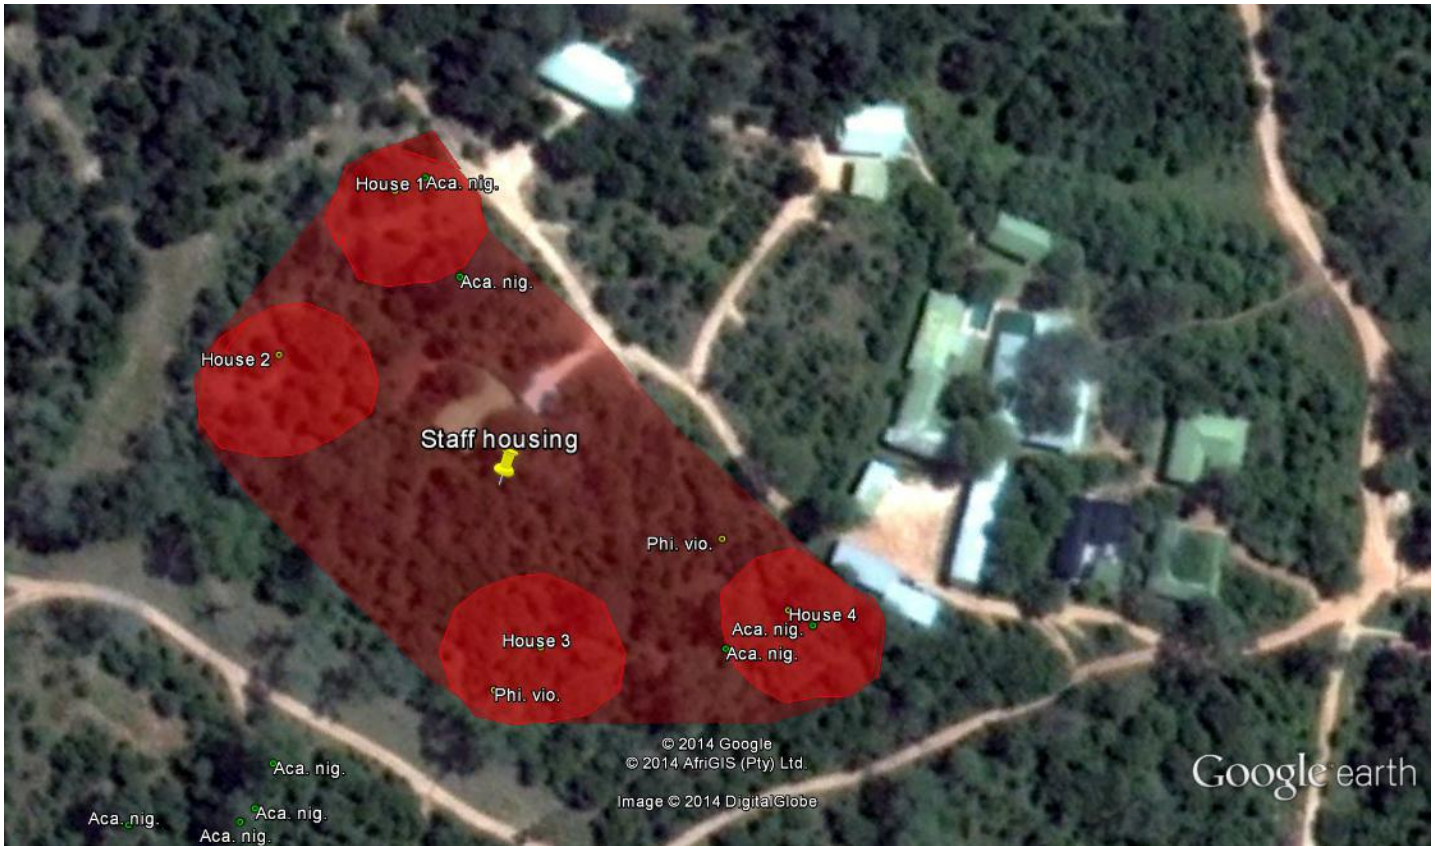
Figure 4: Visual representation of the location of protected trees and significant ecosystem components within the footprint of houses 1, 2, 3 and 4 (Source: Google Earth 2014).

Note: Trees marked with a yellow marker are protected and trees marked with a green marker are large trees which may hinder construction.

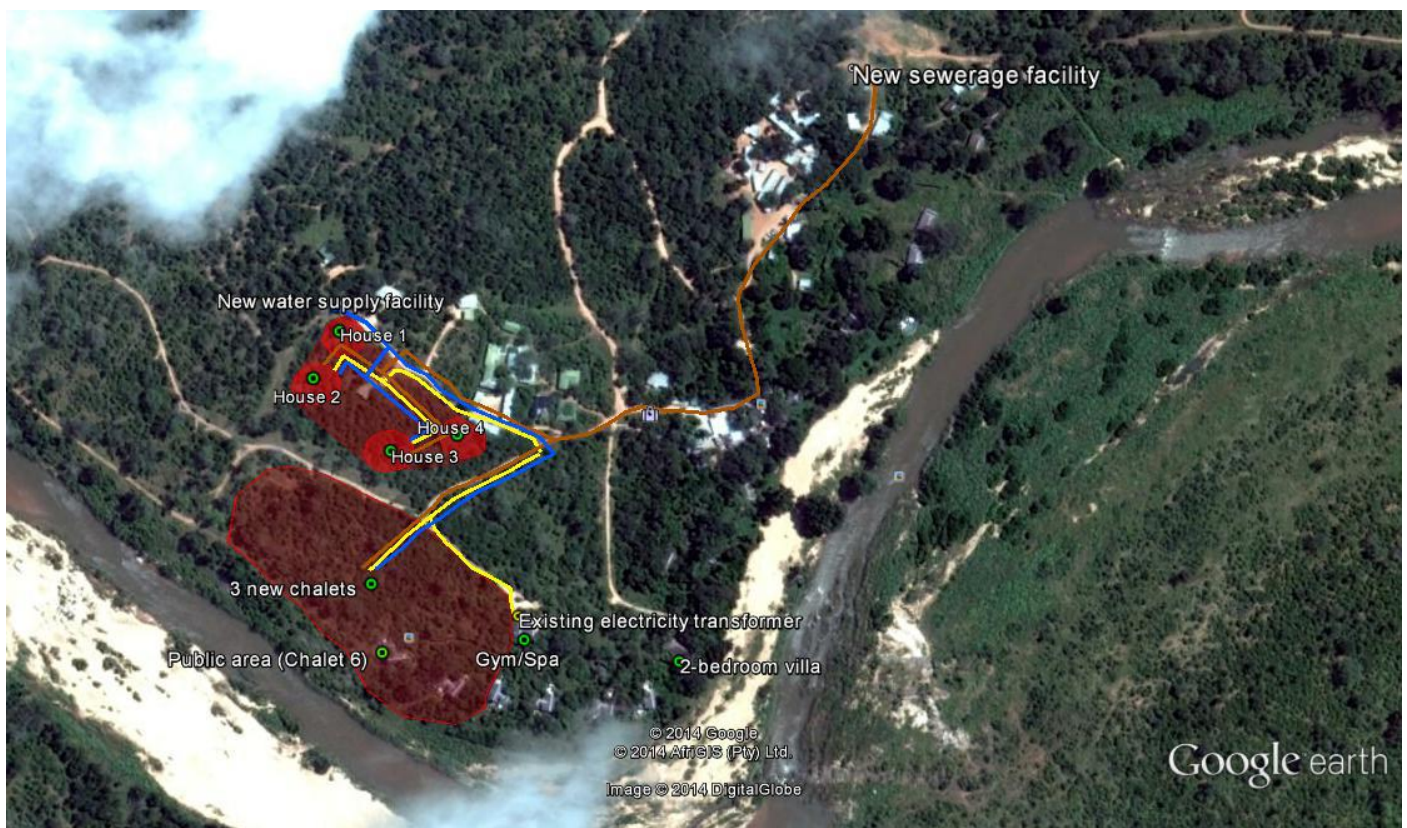
Electricity will be provided to each of the proposed developmental sites by the existing transformer (Matthew Altenkirk *pers. comm.* 9 May 2014). A new water supply facility is being constructed to replace the existing 'Jojo tanks' which are located in close proximity to the new staff housing. A new sewerage facility is also being developed in the north-eastern section of the lodge.

Figure 5 illustrates the potential route each utility service would follow in order to be linked to each of the proposed developmental sites (Note: The exact location of the three new chalets is not known; therefore the probable route each utility service will follow has been sketched to end within the zone which has been demarcated for the proposed development). The new public area will need to be linked up to the new water supply facility and the new sewerage facility, and should remain linked to the existing electricity transformer.

Figure 5: Potential electricity (yellow), water (blue) and sewerage (brown) utility routes which link to the developmental sites (Source: Google Earth 2014).
