**SPECIALIST ECOLOGICAL ASSESSMENT FOR THE
PROPOSED NEW 132kV LINE FROM LYDENBURG
SUBSTATION to MERENSKY SUBSTATION,
NORTHERN REGION;
MPUMALANGA & LIMPOPO PROVINCE**

SUBMITTED: JUNE 2013

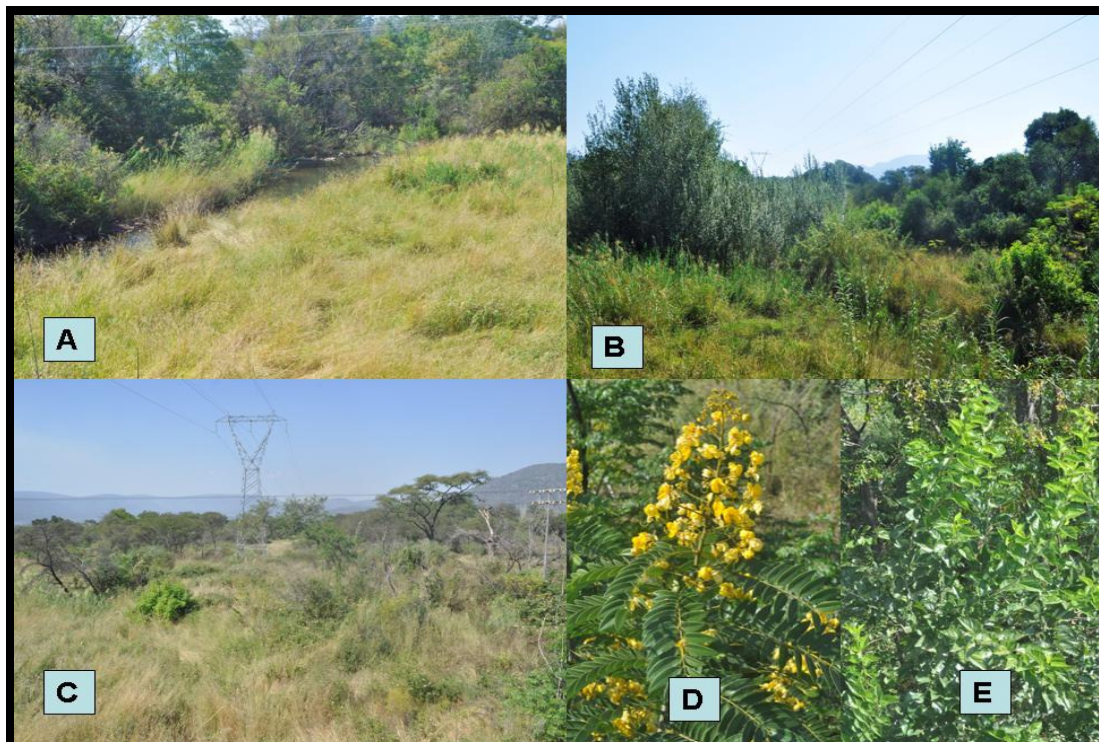
Figure9. A collage of photographs displaying the Subtropical Freshwater Wetlands vegetation unit. A: Situated within the lower-lying areas adjacent to the active channel of the Waterval River is a seasonally inundated flood bench which is dominated by hygrophilous and hydrophilic grasses and sedges. **B:** The riparian zone of the Waterval River is dominated by large *Combretum erythrophyllum* as well as dense patches of White Poplars *Populus alba. var. alba**. **C:** An existing servitude bisects the river and riparian zone. The proposed alignment 1 crossing bisects the riparian zone and will result in the removal of several riparian species including *Combretum erythrophyllum*, *Acacia nilotica*, *Acacia robusta*. **D:** Medium-High infestations of alien vegetation was observed within the riparian zone including Peanut-Butter Cassia (*Senna didymobotrya**) and **E:** White Mulberry (*Morus alba**) as well as Syringa (*Melia azedarach**).

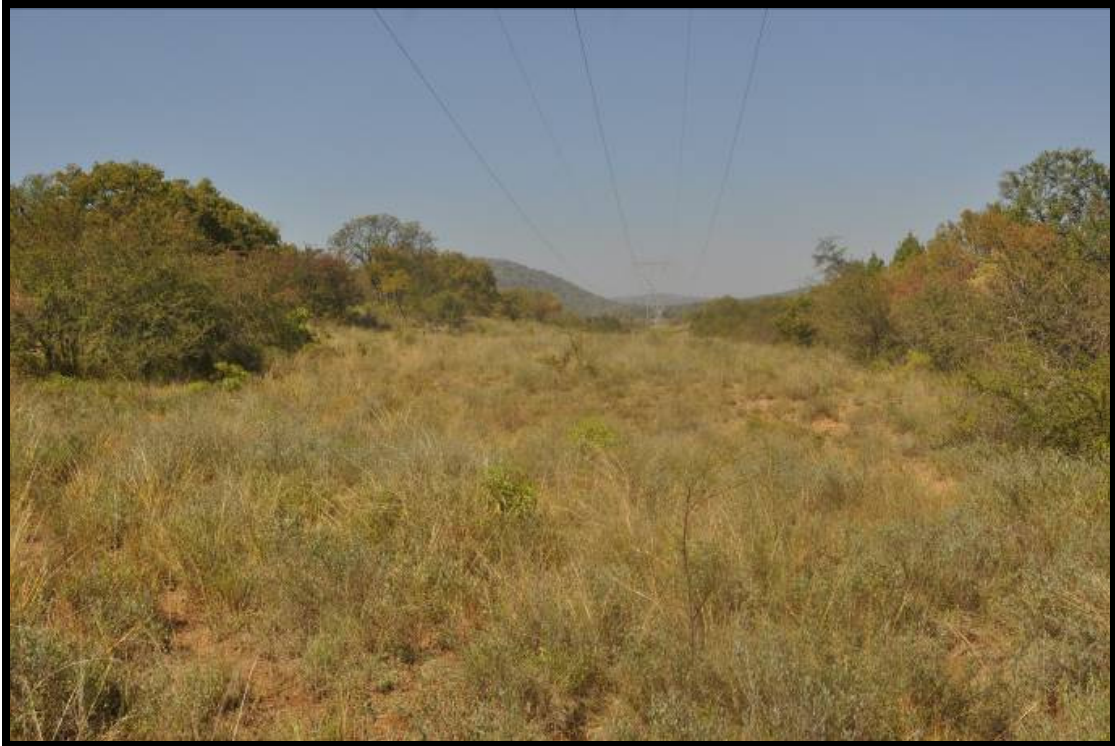
Figure16. Only one alternative alignment occurs adjacent to the Sterkfontein River towards the Merensky substation. The proposed alignment should be shifted approximately 200-300m to the west of the Sterkfontein River and bisect the transformed bushveld areas. The existing servitude has resulted in the clearance of all shrubs and tree layer. High diversity of endemic plant, shrub and tree species occur in this area.
