Jukskei Rejuvenation Project Plant Sensitivity Audit

SUMMARY ASSESSMENT

I surveyed the vegetation along the Jukskei River from the park in Queen Street to Long Street (500 metres) on the 4 April 2018. I identified plants to determine the degree of infestation by problem plants along the canal and took photographs of the vegetation. I also noted factors impacting on the growth of the vegetation.

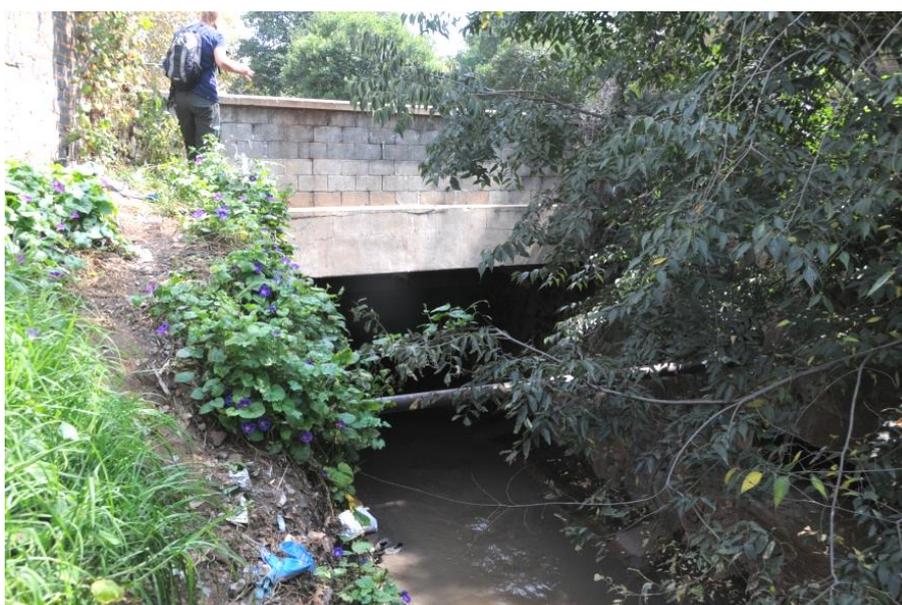
Queen Street: Public access to the canal is possible on both sides of the canal. A White stinkwood tree is visible on the Nandos Central Kitchen bank (right).

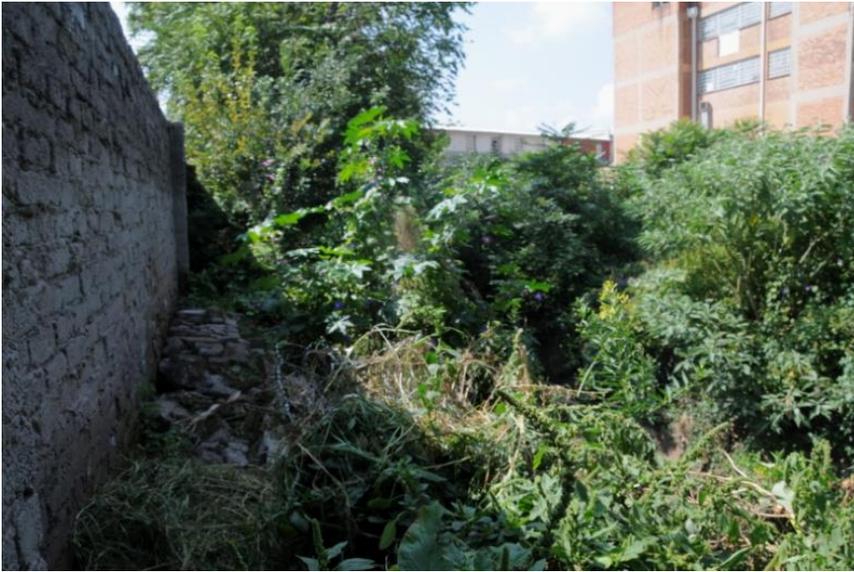
Queen Street: About 2 metres from the entrance to the canal on the Nandos Central Kitchen side. Litter, building rubble and stripped cables are lying here. The shade line created by the brick wall is evident. The absence of large trees of the Tree-of-heaven may make this site viable for the sieve tank, water wheel and vertical and horizontal wetlands. A line of trees occur about 10 metres further along the canal down to Viljoen Street.

There is evidence of use of the canal banks by the public. Human faeces and kitchen refuse litter the entrance to the canal of the bank bordering the Nandos Central Kitchen property, and stripped cables lie further along. A vagrant has erected a shack in the open plot next to a building of flats on the opposite bank. The open plot has many invasive plants growing in it which need to be removed. Builders have left rubble on much of the bank bordering the Nandos Central Kitchen property. The canal banks and area around the canal access points will need to be cleared of rubbish and fertilised before planting to riverine and wetland plant species along the whole canal from Queen to Long Street. Access to the canal needs to be controlled and additional fencing put up at the open lot and over the Queen Street bridge.

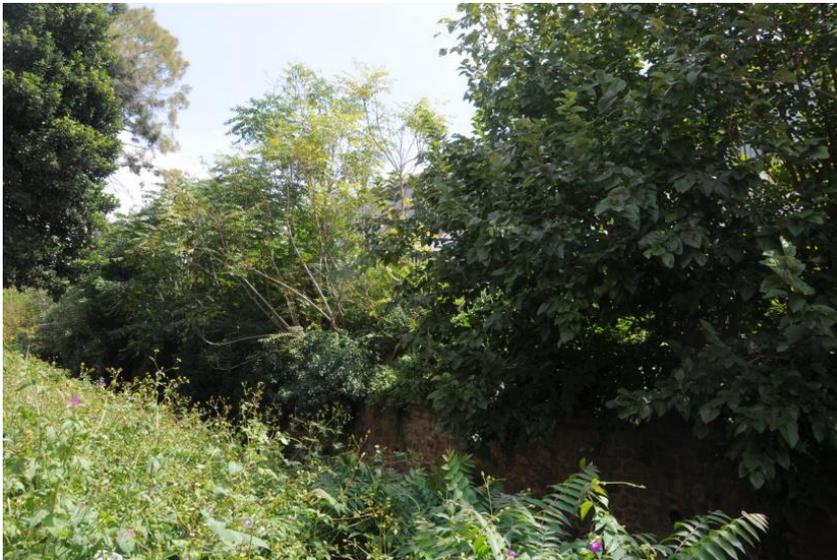
Mid section close to the gate of the Nandos Central Kitchen property as seen from the opposite bank: The trees are taller than on the opposite bank.

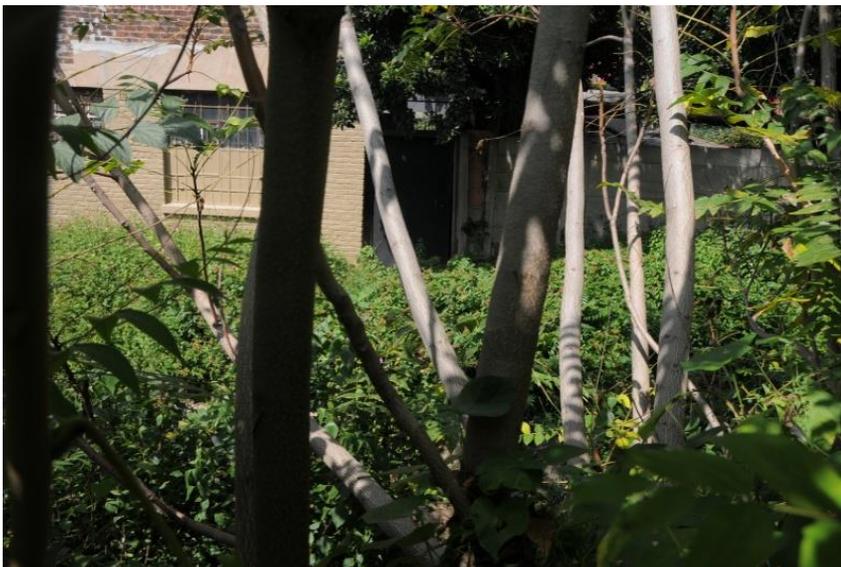
Mid section as seen from the Nandos Central Kitchen bank. Under the canopy of Tree-of-heaven and other species, in places where the Crofton weed is less dense, a variety of plants grow in the understory.

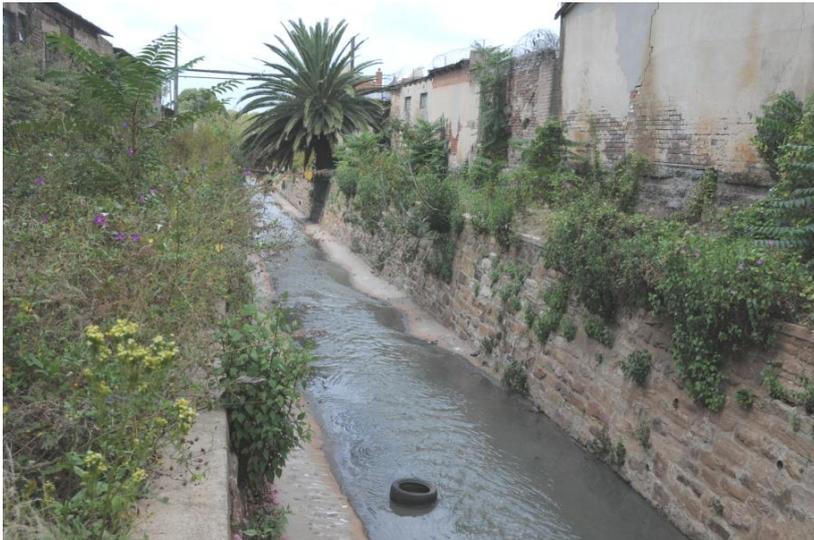
From Viljoen Street: The Victoria Yards bank (left) is heavily infested with Black Jack, Khaki bos and other weed species after the vegetation was removed and no follow up occurred. The soil has remnants of cement and is hard and dry though moss is growing on the building walls.

Inappropriate weed control was used on the bank of the canal bordering the Victoria Yards property. The vegetation was removed using a bulldozer about seven months ago. No follow-up programme has been implemented with the result that the vegetation is now dense with weeds and alien plants. It is important that once the plants have been removed that a continuous weeding and alien plant control plan is followed.

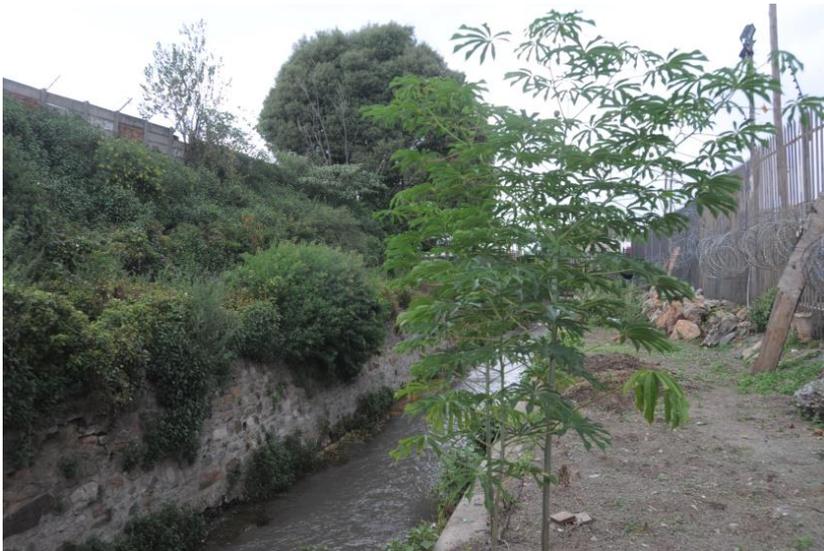
Long Street ahead: The vegetation is dense on the Victoria Yards bank (left). A vegetable garden has been made on the opposite bank (right). The vegetable garden should be removed.

A vegetable garden has been established on the southern bank of the canal near Long Street by employees of the business operating there. This will have to be removed together with the new drain channel that has been placed on top of the bank to drain into the canal.

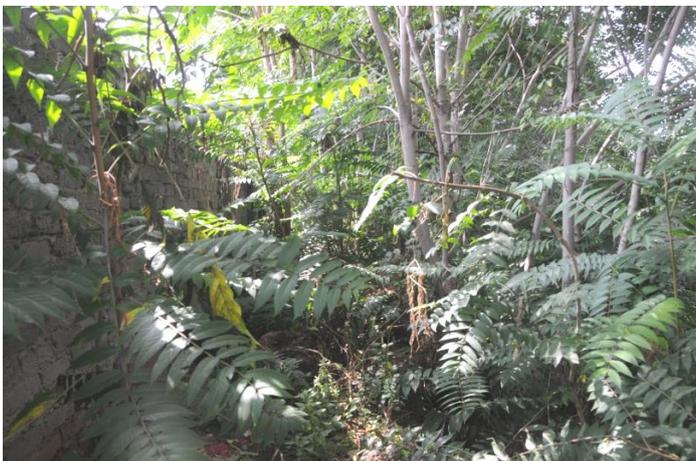
Tree-of-heaven (*Ailanthus altissima*)

A decorative deciduous tree that grows easily from seed and forms suckers from cut stems and roots. The roots tend to expand into water systems. The plants have separate sexes (unisexual) or are bisexual and produce many winged-seeds (samaras) in October-November. These can be dispersed by wind and water. The plant grows rapidly up to a height of 25m. It also produces a chemical which prevents the growth of other species (alleopathic). The plant

parts have medicinal uses. Other uses are as a wood fuel and for furniture making.

Small plants less than 2 metres should be dug out, taking care to remove the whole root system. Larger plants need a combination of cutting the stem and painting the stem with herbicide. There is no registered chemical for this species. A suggestion is to make many small cuts downwards all around the stem. Apply Garlon into the cuts. This should be followed with repeated cutting of the shoots as they appear to use up the energy stored in the roots. Then dig up the plant. The younger trees can be cut down and the shoots repeatedly cut thereafter as their roots are not large.

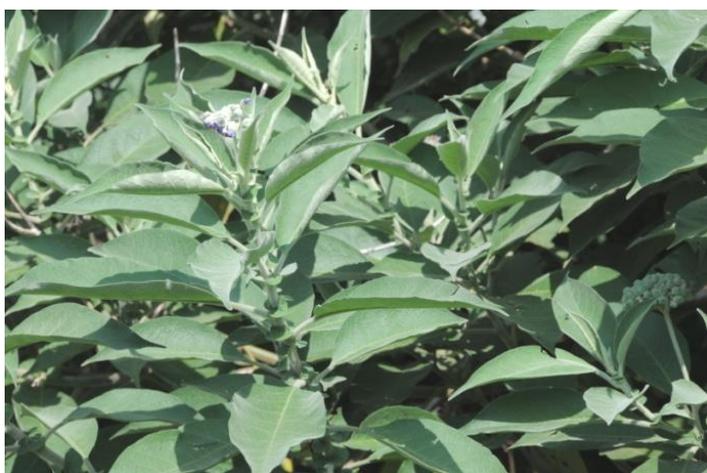
Bugweed (*Solanum mauritianum*)

A perennial evergreen shrub or small tree of 5m. It grows quickly and shades out other vegetation. It produces poisonous berries which attract fruit flies and birds which disperse the seeds. It is easy to control by cutting down and painting the stem with herbicides. Care must be taken with the fine hairs released from the stems which can cause breathing problems.

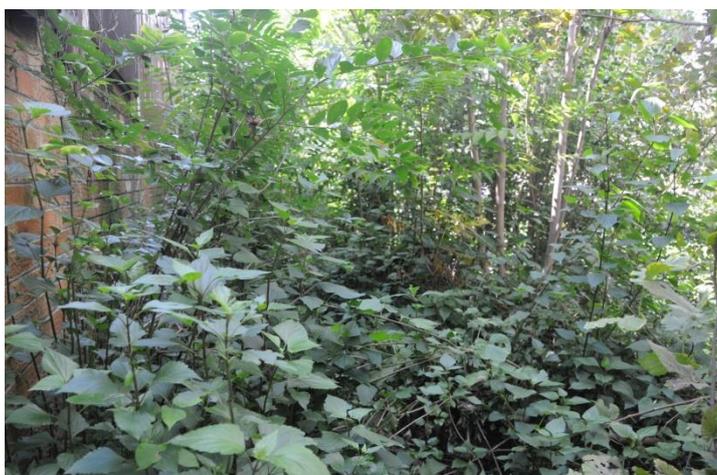
Crofton weed (*Ageratina adenophora*)

A multi-stemmed dark green evergreen soft woody shrub, it grows up to 2 metres high and produces wind dispersed achenes from December. It is poisonous to livestock. It competes and replaces other plant species forming monocultures and has no uses. The plants need to be cut back and then pulled out.

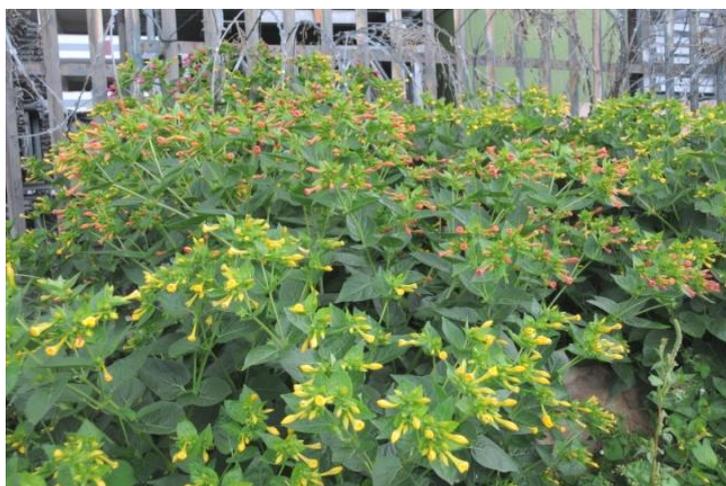
Four –o'clock plant (*Mirabilis jalapa*)

A perennial shrub that grows up to 2 metres. The flowers open in the afternoon and close the next morning. It reproduces from seed and grows during the rainy season. The plant and seeds (one seeded capsule) are poisonous. The plant replaces other plants. It is controlled only by mechanical removal.
